Mobile Intel® Pentium® 4 Processor-M

Specification Update

December 2006

Document Number: 250721-037

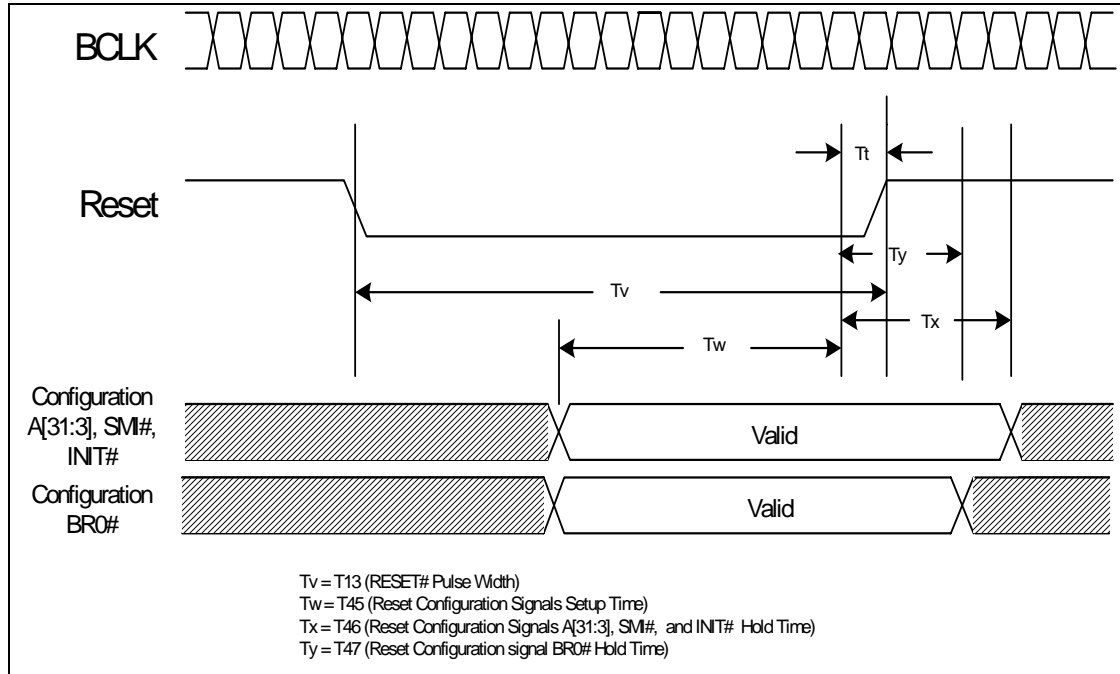
Figure 13. System Bus Reset and Configuration Timings

The BR0# maximum hold time has changed to 2 BCLKs. This change will be shown in the “System Bus AC Specifications (Reset Conditions)” table and “System Bus Reset and Configuration Timings” figure of the *Mobile Intel® Pentium® 4 Processor - M Datasheet*. This change will be incorporated in the next revision of the datasheet.

The following figure will be modified to reflect this change:
