Monthly Specification Update

Intel® Server Board S5000PAL

Intel® Server System SR1500AL

Intel Order Number D65289-036

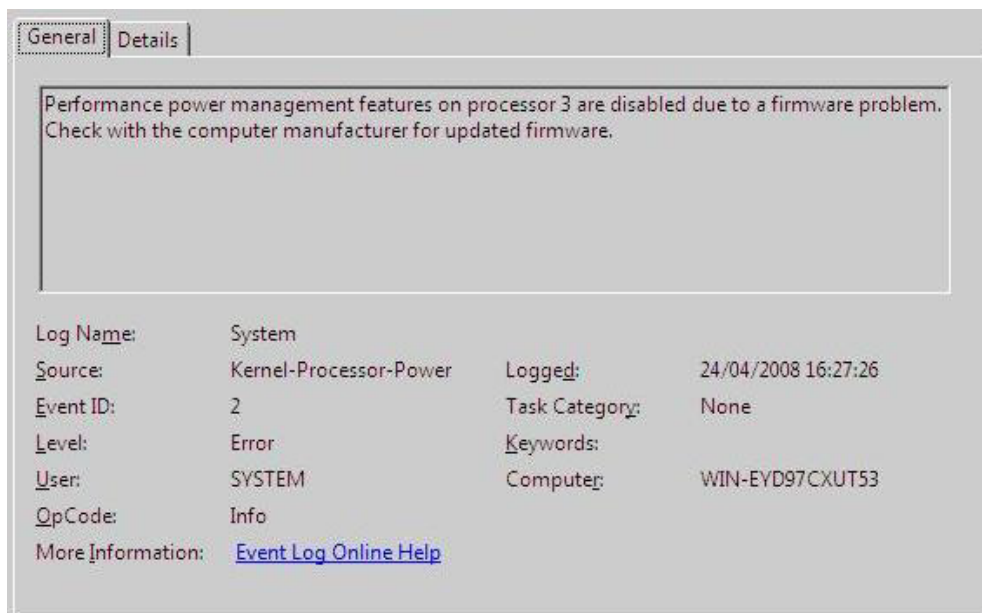
57. Performance Power Management Error in Microsoft Windows Server 2008*

Problem	If you are use any Intel® Xeon® Processor of the 5300 or the 5400 series in the Intel® S5000PAL Server Board and install Microsoft Windows Server 2008* on the system, you may encounter the following error in the Windows* event log:
---------	---

The Event Error is related to a change in Microsoft's validation and logging of supported P-States for a processor. The wording of the error that is displayed is misleading. There is no performance impact. Microsoft logs the error because the BIOS has a default PSS object (P-State info) in the ACPI space for these processors. Basically, this default PSS object indicates no P-State is supported. However, Microsoft Windows Vista* and Microsoft Windows Server 2008* have changed their interpretation of this table.

Implication	BIOS version 88 or even an earlier version may produce this erratum.
-------------	--

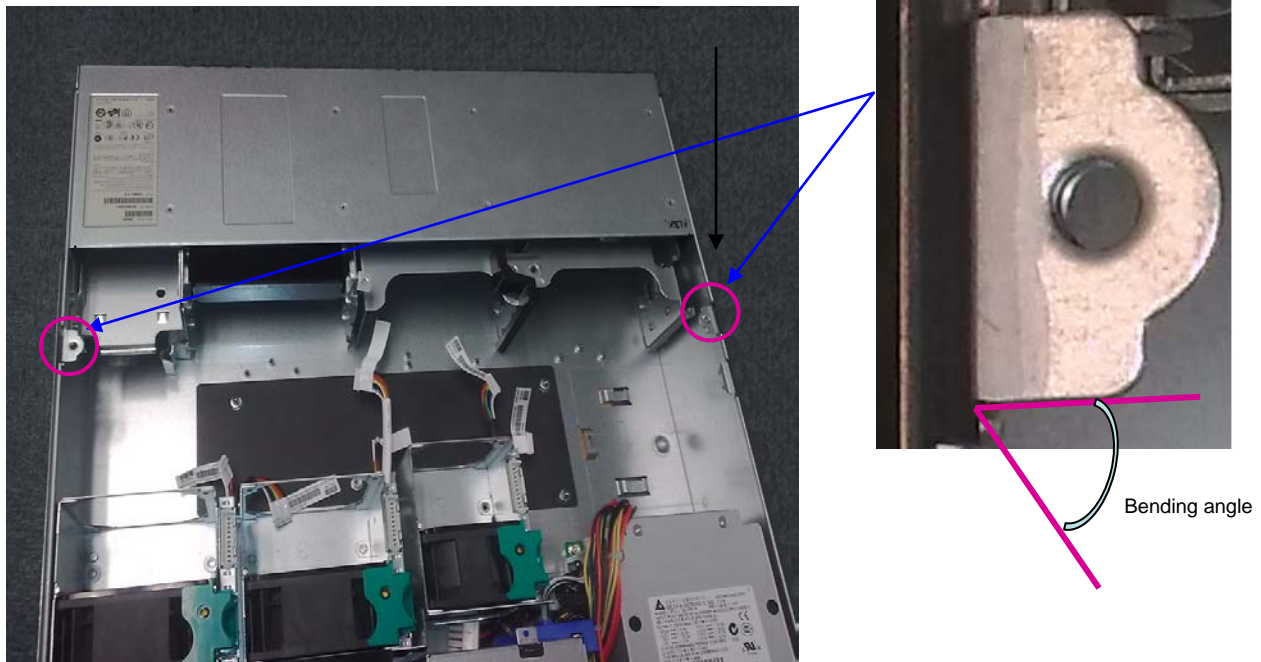
63. Hard Disks Are Difficult to Install in Intel® Server System SR2500AL and Intel® Server Chassis SR2500

Problem	Customers may find it difficult to properly and fully install the hard drives into the hard drive slots. This is because the backplane is about 0.5-1.5 mm vertically higher than the specification.
Status	This erratum has been fixed.
Workaround	Check to ensure the bottom of the backplane touches the chassis base. If there is an obvious gap, check the two bending features (shown below) and make sure the bending angle is no more than 90 degrees. If necessary, use flat-nose pliers to bend these two features down to lower the backplane. Contact your local Intel Customer Service for more information.

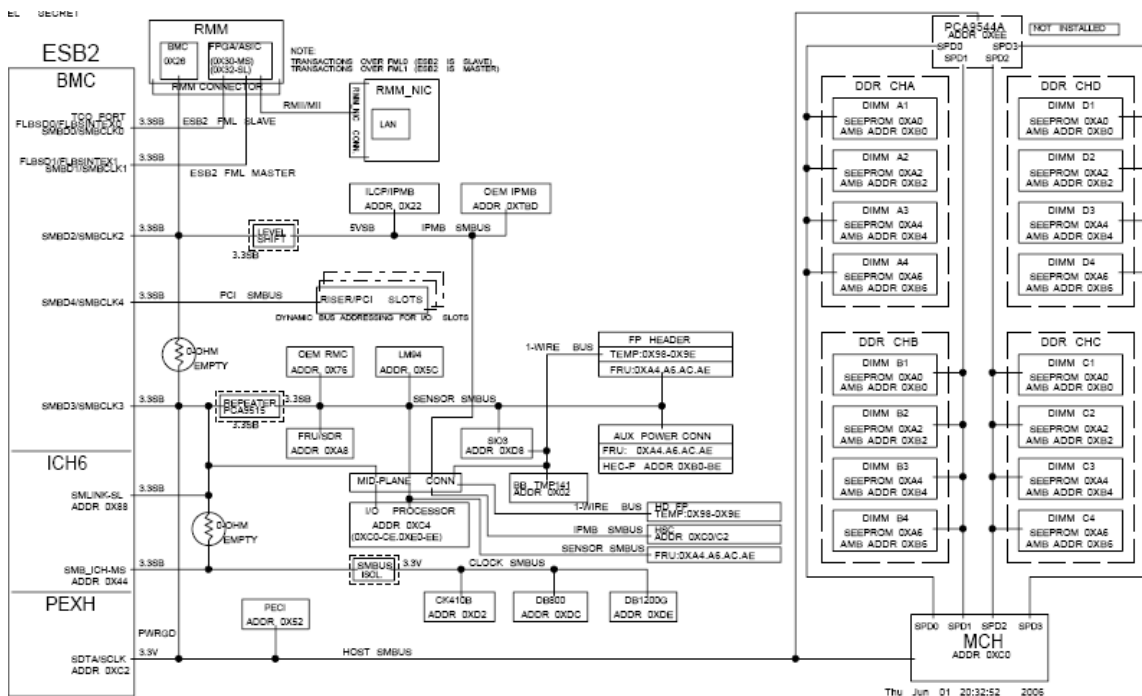
- Add PECI controller
- Remove separate HSC connector
- Correct Midplane -> FP SMBus connections and 1-wire temp sensor
- Correct SMBus and 1-wire temp sensor connections to FP connector
- Correct FBDIMM labeling

The corrected diagram is shown:

Implication: Inaccurate understanding of actual server board design with respect to the specified diagram.

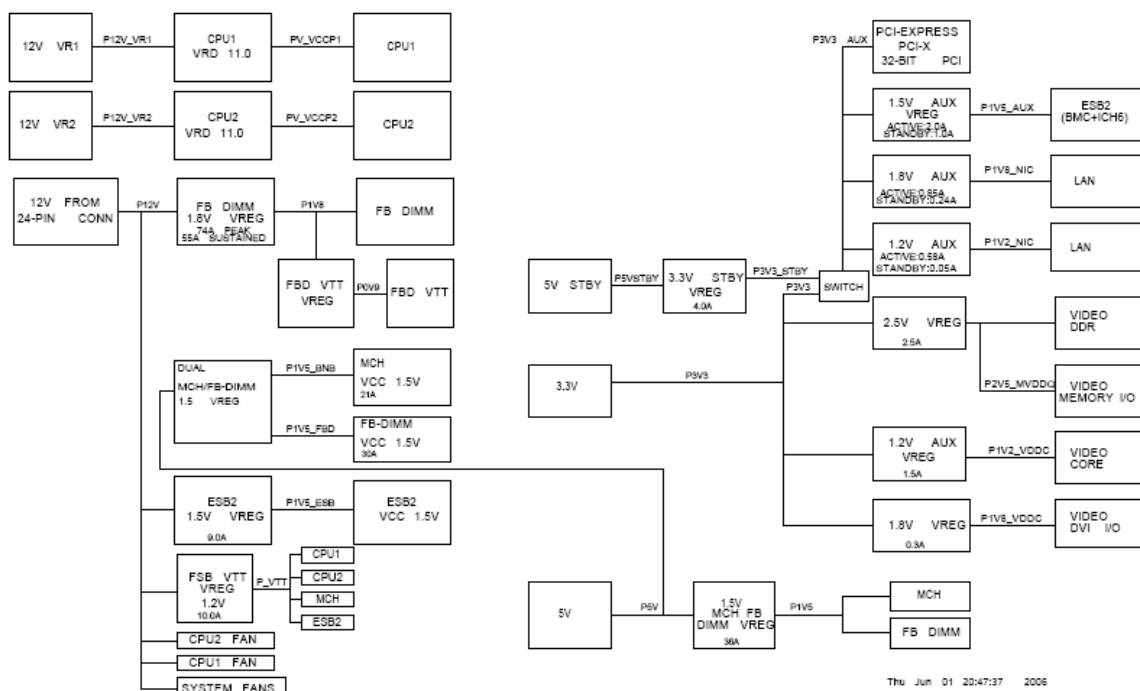
- MCH/FBDIMM 1.5 Vreg moved from 12 V rail to 5 V rail.
- Video Memory Vreg corrected to only one 2.5 V reg. instead of two.
- “ATI” label for Video components changed to generic “Video”.

The corrected diagram is shown:

Implication: Inaccurate understanding of actual server board design with respect to specified diagram.

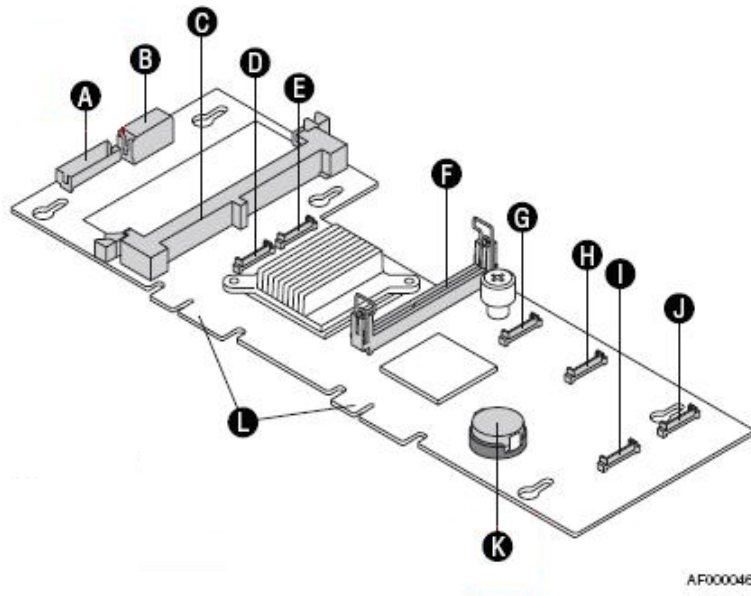
Figure 22. SAS/SAS RAID Mid-plane Board

The chassis also supports an active SAS / SAS RAID mid-plane. This system board incorporates an LSI* LSI SAS1068 SAS controller onto the board. See Chapter 5 for details describing SAS / SAS RAID support. The following diagram shows the location for each connector found on this board.

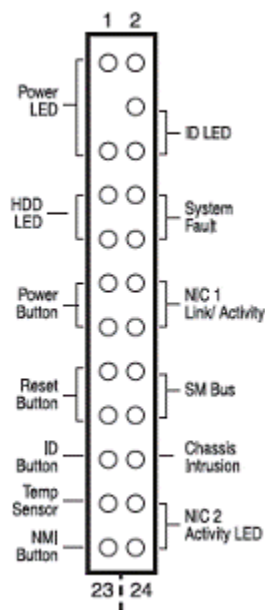
4. Front panel pin-out in the Intel® Server Board S5000PAL Quick Reference Label is incorrect

Problem: The current diagram incorrectly lists a cooling status pin, does not have the temperature sensor listed, and shows incorrect locations for the ID LED. The corrected diagram is shown:

Implication: This is a typo.
