Monthly Specification Update

Intel[®] Server Board S5520UR

Intel Order Number E69054-001

March 2010

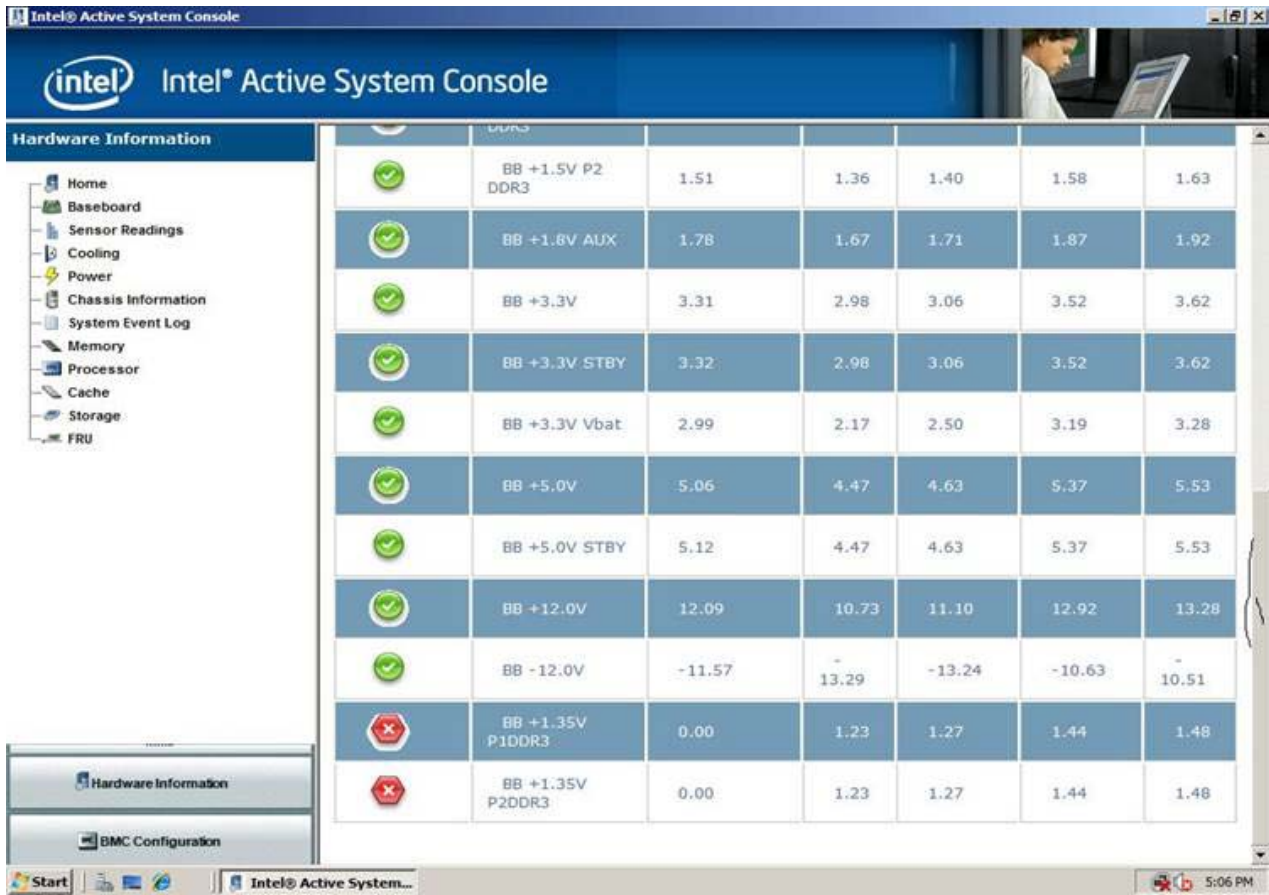
37. Intel(R) Active System Console (IASC) 3.5.1 and 3.5.2 may fail to detect status of memory voltage sensors

Problem	<p>Intel® Active System Console (IASC) v3.5.1 and v3.5.2 is used to monitor hardware status on Intel server system.</p> <p>Intel® Server Board S5520UR start to support low voltage memory DIMM, so current FRUSDR has contained four memory voltage sensors "BB+1.5v P1DDR3", "BB+1.5v P2DDR3", "BB+1.35v P1DDR3" and "BB+1.35v P2DDR3", When system has 1.5v memory or 1.35v memory, only corresponding memory voltage sensors will be enabled, the other type memory voltage sensors will be disabled.</p> <p>IASC cannot judge the status of memory voltage sensors which have been disabled, and still try to detect those sensors reading. Because sensor reading is "0", lower than its threshold, so IASC shows those sensors status as critical warning.</p> <p>Below is screen shoot of this failure</p>
---------	--

Implication IASC fails to judge the status of disabled sensors and still considers those sensors to server health algorithm.

Status This issue will be fixed on next IASC release.

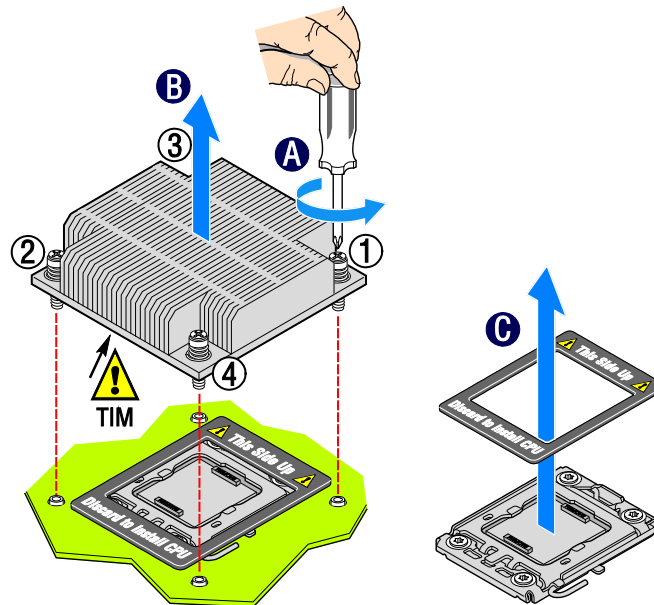
Figure 1. Removing the Heatsink

Problem: The current documentation does not properly describe the installation and removal of the heatsink. Careful insertion and removal of the heatsink is required to prevent damage to the heatsink screws or backplate.

Implication: There is a possibility of damage to the heatsink if proper steps are not followed.

1. Loosen the four captive screws on the heatsink corners in a diagonal manner according to the numbers shown in figure 1 as follows:
 - Starting with the screw at location 1, loosen it by giving it **two rotations** in the anticlockwise direction and stop. (**IMPORTANT:** Do not fully loosen.)
 - Proceed to the screw at location 2 and loosen it by giving it two rotations and stop.
 - Loosen screws at locations 3 and 4 by giving each screw two rotations and then stop.
 - Repeat steps 1a through 1c by giving each screw two rotations each time until all screws are loosened.
2. Do one of the following:
 - If removing the heatsink for the first time, do the following:
 - i. Lift the heatsink from the board.
 - ii. Remove and discard the spacer (see letter “C” in figure 1).

- If a processor is already installed, do the following:
 - i. Twist the heatsink slightly to break the seal between the heatsink and the processor.
 - ii. Lift the heatsink from the processor. If it does not pull up easily, twist the heatsink again. Do not force the heatsink from the processor. Doing so could damage the processor.

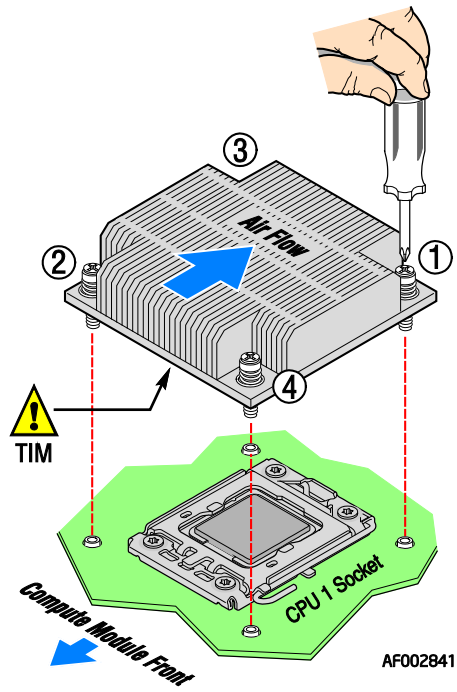
Figure 2: Installing the Heatsink

CAUTION: The heatsink has Thermal Interface Material (TIM) located on the bottom of it. Use caution when you unpack the heatsink so you do not damage the TIM.

1. Remove the protective film on the TIM if present.
2. Orient the heatsink over the processor as shown in Figure 2. The heatsink fins must be positioned as shown to provide correct airflow through the system.
3. Set the heatsink over the processor, lining up the four captive screws with the four posts surrounding the processor.

4. Loosely screw in the captive screws on the heatsink corners in a diagonal manner according to the numbers shown in Figure 2 as follows:
 - a. Starting with the screw at location 1, engage the screw threads by giving it **two rotations** in the clockwise direction and stop. (**IMPORTANT:** Do not fully tighten.)
 - b. Proceed to the screw at location 2 and engage the screw threads by giving it two rotations and stop.
 - c. Engage screws at locations 3 and 4 by giving each screw two rotations and then stop.
 - d. Repeat steps 4a through 4c by giving each screw two rotations each time until all screws are lightly tightened upto a maximum of 8 inch-lbs torque.
