Monthly Specification Update

Intel® Server Board S5520UR

Intel Order Number E69054-001

March 2013

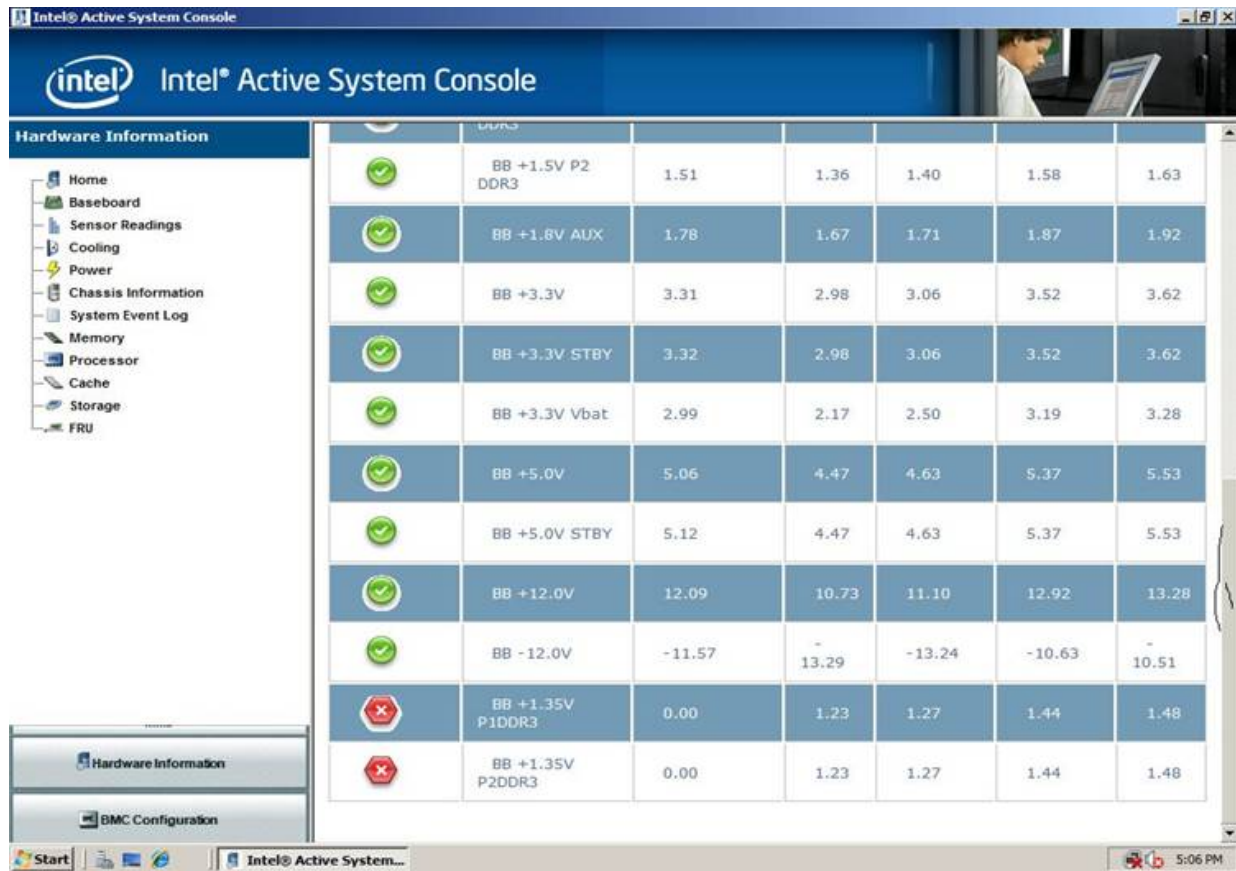
Problem	<p>Intel® Active System Console (IASC) v3.5.1 and v3.5.2 is used to monitor hardware status on Intel server system.</p> <p>Intel® Server Board S5520UR start to support low voltage memory DIMM, so current FRUSDR has contained four memory voltage sensors "BB+1.5v P1DDR3", "BB+1.5v P2DDR3", "BB+1.35v P1DDR3" and "BB+1.35v P2DDR3", When system has 1.5v memory or 1.35v memory, only corresponding memory voltage sensors will be enabled, the other type memory voltage sensors will be disabled.</p> <p>IASC cannot judge the status of memory voltage sensors which have been disabled, and still try to detect those sensors reading. Because sensor reading is "0", lower than its threshold, so IASC shows those sensors status as critical warning.</p> <p>Below is screen shoot of this failure</p>
---------	--

Implication IASC fails to judge the status of disabled sensors and still considers those sensors to server health algorithm.

Status This issue will be fixed on next IASC release.

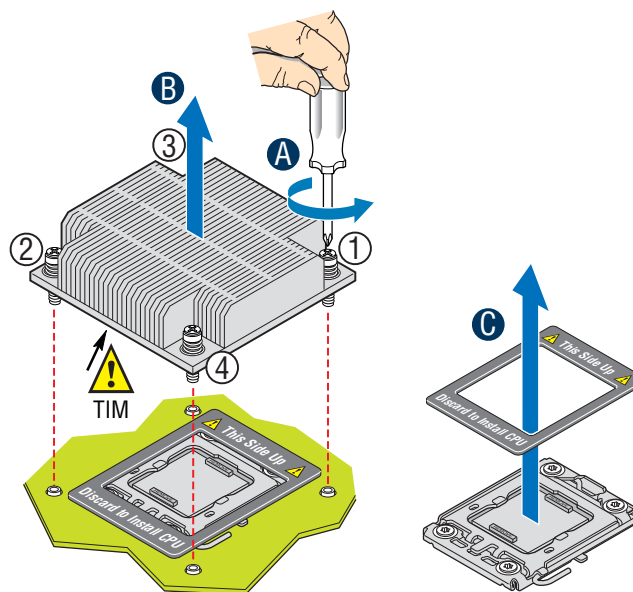
Figure 1. Removing the Heatsink

- Problem:** The current documentation does not properly describe the installation and removal of the heatsink. Careful insertion and removal of the heatsink is required to prevent damage to the heatsink screws or backplate.
- Implication:** There is a possibility of damage to the heatsink if proper steps are not followed.
- Status:** Corrections incorporated into the latest version of the following Service Guides:
- Intel® Server System SR1600 Service Guide (Intel Order Number: E52880-003)
 - Intel® Server System SR1625 Service Guide (Intel Order Number: E52881-003)
 - Intel® Server System SR2600/SR2625 Service Guide (Intel Order Number: E51243-003)
- Workaround:** Perform the steps outlined below for installation and removal of the heatsink to avoid damage.

1. Loosen the four captive screws on the heatsink corners in a diagonal manner according to the numbers shown in figure 1 as follows:
 - Starting with the screw at location 1, loosen it by giving it **two rotations** in the anticlockwise direction and stop. (**IMPORTANT:** Do not fully loosen.)
 - Proceed to the screw at location 2 and loosen it by giving it two rotations and stop.
 - Loosen screws at locations 3 and 4 by giving each screw two rotations and then stop.
 - Repeat steps 1a through 1c by giving each screw two rotations each time until all screws are loosened.
2. Do one of the following:
 - If removing the heatsink for the first time, do the following:
 - i. Lift the heatsink from the board.
 - ii. Remove and discard the spacer (see letter "C" in figure 1).

- If a processor is already installed, do the following:
 - i. Twist the heatsink slightly to break the seal between the heatsink and the processor.
 - ii. Lift the heatsink from the processor. If it does not pull up easily, twist the heatsink again. Do not force the heatsink from the processor. Doing so could damage the processor.

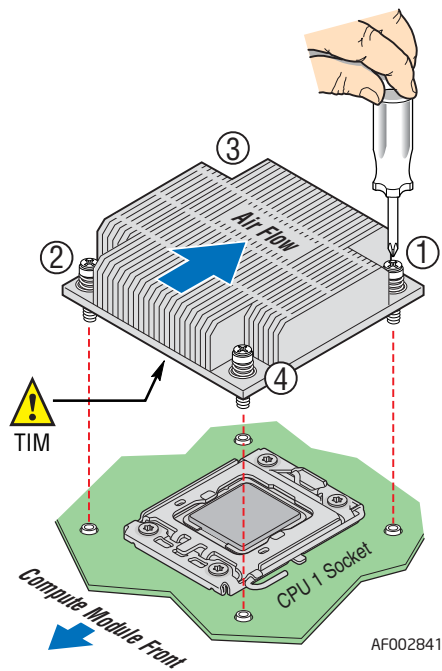
Figure 2: Installing the Heatsink

CAUTION: The heatsink has Thermal Interface Material (TIM) located on the bottom of it. Use caution when you unpack the heatsink so you do not damage the TIM.

3. Set the heatsink over the processor, lining up the four captive screws with the four posts surrounding the processor.
4. Loosely screw in the captive screws on the heatsink corners in a diagonal manner according to the numbers shown in Figure 2 as follows:

- b. Proceed to the screw at location 2 and engage the screw threads by giving it two rotations and stop.
 - c. Engage screws at locations 3 and 4 by giving each screw two rotations and then stop.

- d. Repeat steps 4a through 4c by giving each screw two rotations each time until all screws are lightly tightened upto a maximum of 8 inch-lbs torque.
