Intel Technical Advisory

TA-0959-1

July 2, 2010

Intel® Server System S7000FC4UR with PBA #D56804-703 may experience an intermittent BMC issue

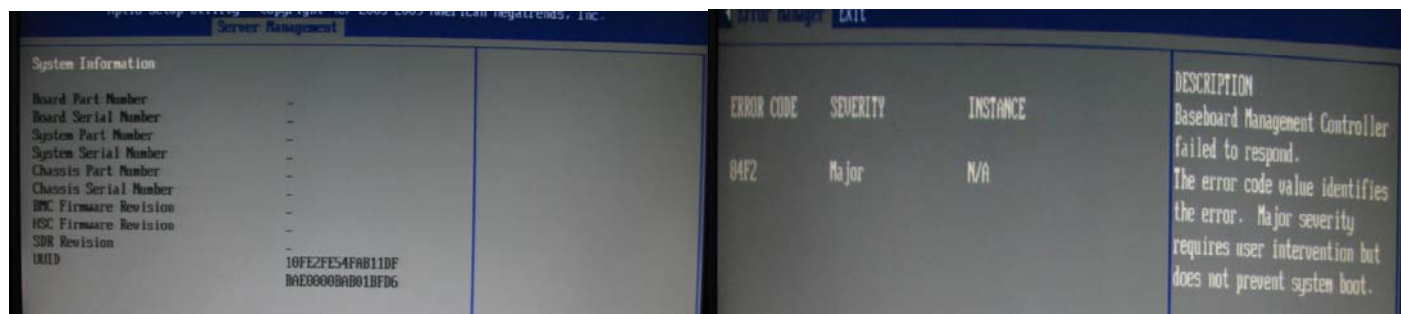
Intel has identified an issue with the BMC on baseboards with PBA #D56804-703. When the issue occurs upon initial AC power on, the status LED does not display the normal yellow/green flashing sequence. The fan speed control is not active and erratic fan control will occur. The system information page of BIOS setup utility is empty and error code "84F2" is logged by the error manager:

Failure analysis has indicated that the issue is caused by the flash component which stores the BMC image. The supplier confirmed a silicon design issue where the first read to the flash component upon AC power-on can result in incorrect data when reading address 00h of the component. The issue only occurs on A/C power up and does not affect run-time operation.

Intel implemented a header change in BMC v23 firmware to work around this issue. There is no boot code or operational code change involved in BMC v23 firmware.

Intel released BMC v23 firmware and will rework current factory inventory to implement this workaround. For long term corrective action, the supplier is implementing a mask change of the flash component to correct this issue in hardware. Qualification of the revised component and potential cut-in to production of S7000FC4UR systems is TBD. The current software work around in BMC v23 firmware is a 100% solution. The flash component supplier confirmed that all components are susceptible to this issue. Intel recommends that all baseboards with PBA# D56804-703 be updated with the BMC v23 firmware.
