intel® Action Alert

AA-0760-3

June 21, 2005

Intel® Server Chassis SR2400 - Active PCI-X Riser Card Option Heat Sink Falling Off

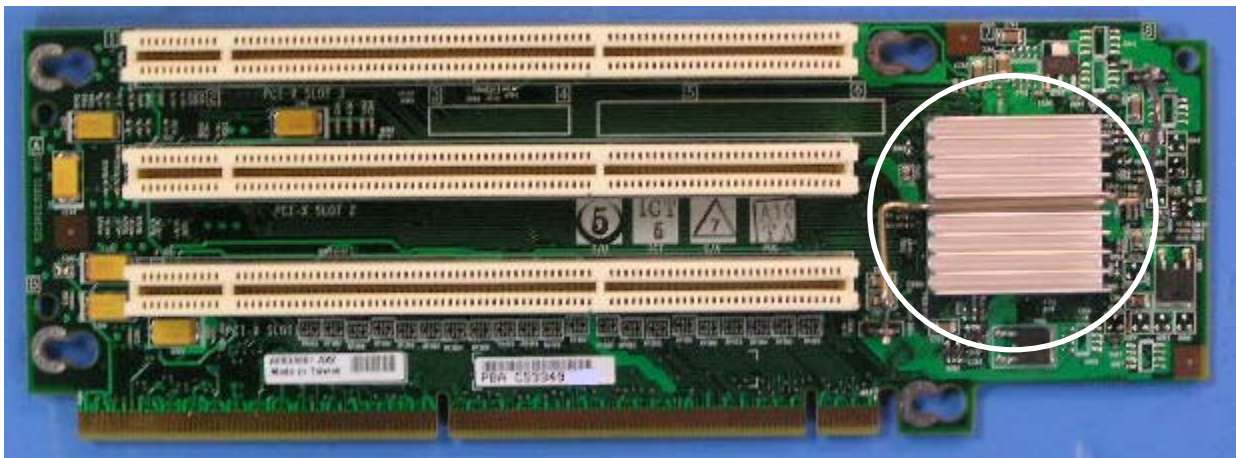
Figure 1: PCI-X Active Riser Card for the Intel Server Chassis SR2400

Intel believes that a long term reliability issue may exist with the Active PCI-X riser card where, over time within the warranty period, the on board heat sink may detach and fall off. See Figure 1 below.

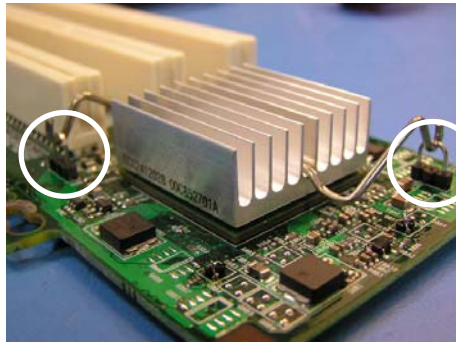
Figure 2: Active PCI-X Riser Card Heat Sink and Retention Mechanism

Intel has determined that the solder joints for the U-Anchors used to hold down the heat sink retention clip, may fail over time. Time to failure is highly dependent on system configuration and operating environment. Failure analysis testing has shown that system configurations consisting of several high load add-in cards and/or systems operating in high ambient temperatures may experience a solder joint failure within 2-3 months after deployment. Lesser configurations and/or systems running in lower ambient temperatures may experience a solder failure 9–15 months after deployment.

If a U-anchor failure were to occur, it is possible for the loose heat sink or U-anchor to cause an electrical short on the baseboard causing the server to power off. To date, reported failure data has not indicated any loss of data or specific safety issue related to the system level product.

Intel has identified a new 'J' hooked U-Anchor design. The new U-Anchor design will retain its hold on the board should its solder joints ever fail, preventing the heat sink from falling off.
