# Monthly Specification Update

**Intel® Server Boards S2600WP Family**  
**Intel® Server Systems H2000WP Family**

*Intel Order Number G64830-007*

**September, 2013**

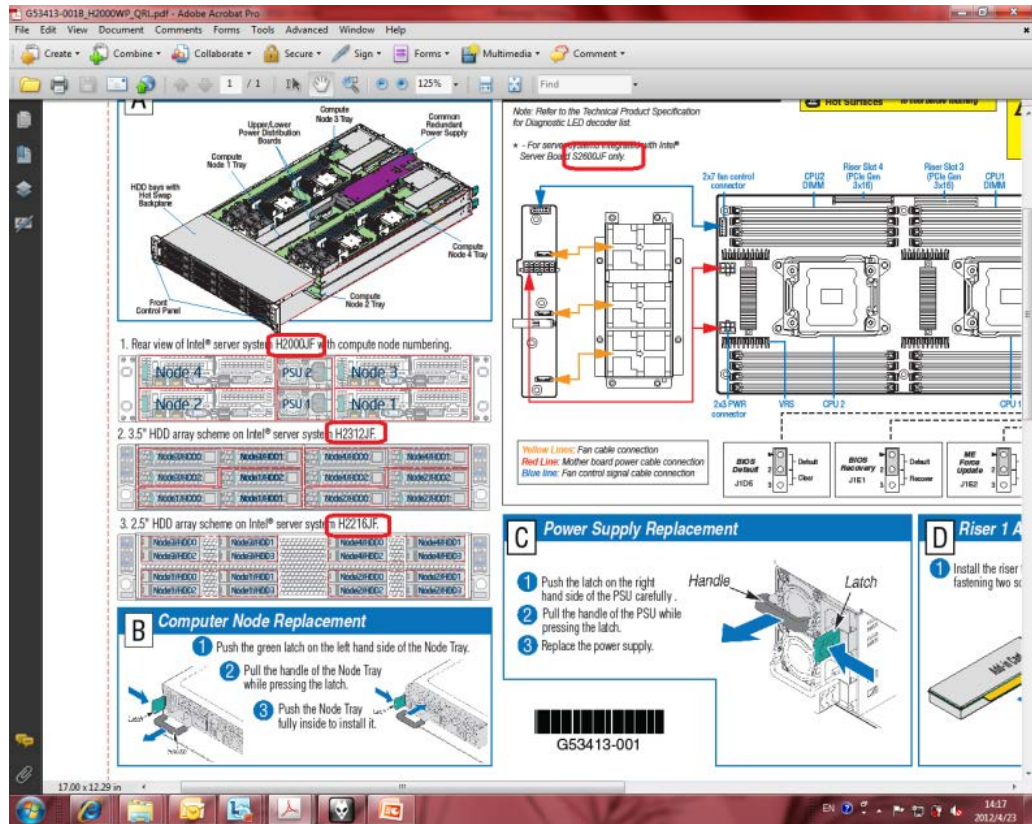
Figure 1. The Chassis Quick Reference with Incorrect Picture Titles

Problem The *Intel® Server System H2000WP Family Chassis Quick Reference* (document ID G53413-001) has four incorrect picture titles as shown below. The correct title names should be "H2000WP", "H2312WP", "H2216WP", and "S2600WP". All schemes and configuration diagrams are correct for H2000WP. The impacted servers systems are listed in the table below. This problem has been fixed in the updated Chassis Quick Reference (document ID G53413-002).

Implication The picture titles do not match the pictures.
