# **Intel<sup>®</sup> Server Boards S5000PSL and S5000XSL**

## ***Specification Update***

*Intel Order Number D62900-001*

**September 2009**

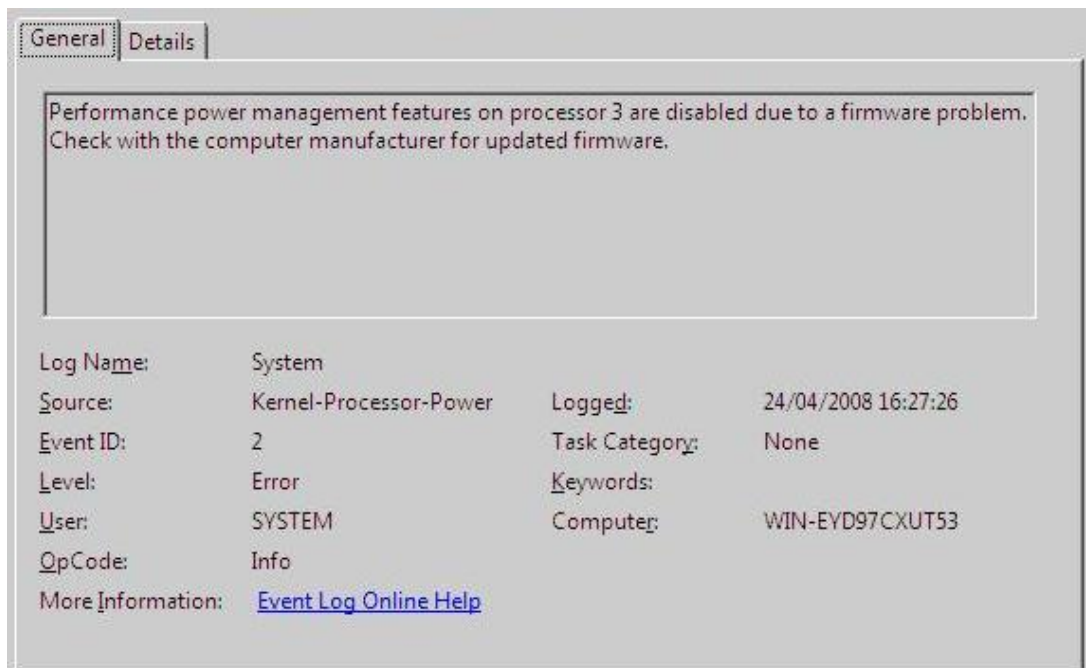
## 51. Microsoft Windows\* Server 2008 and/or Microsoft Windows Vista\* may report Performance Power Management error

**Problem** Microsoft Windows\* Server 2008 and/or Microsoft Windows\* Vista in Intel® Server Board S5000PSL and/or Intel® Workstation Board may have a Performance Power Management error in the Microsoft Windows\* System Event Log like the following illustration:

**Implication** Current version of the BIOS displays a default dummy PSS object (P-State info) in ACPI space for processors that do not support Enhanced Intel® SpeedStep® Technology to indicate no P-State supported; however, this is interpreted as a Performance Power Management error in the Operating System log. This is a harmless message and does not impact system performance or functionality.

**Status** This erratum is fixed by BIOS91.6
