Monthly Specification Update

**Intel® Server Board S2400EP Family, Intel®
Server System R1000EP Family**

October, 2012

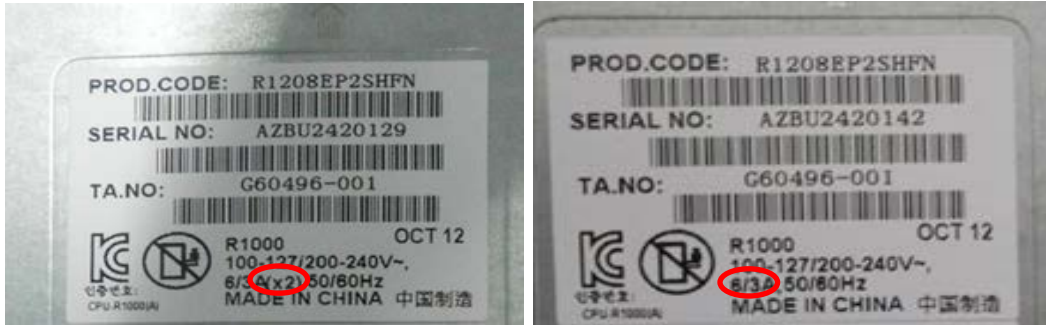
27. Intel® server system R1000EP COO label includes inaccurate information

Problem	Intel® server system R1000EP COO label includes redundant information that needs to be removed.
Implication	There is “x2” follwing powerating “6/3A”, which is showed in the left snapshot. The correct label should be as the right snapshot indicates.

Status This issue may be fixed in future shipment.
