Monthly Specification Update

Intel® Server Board S5520UR

Intel Order Number E69054-001

April 2009

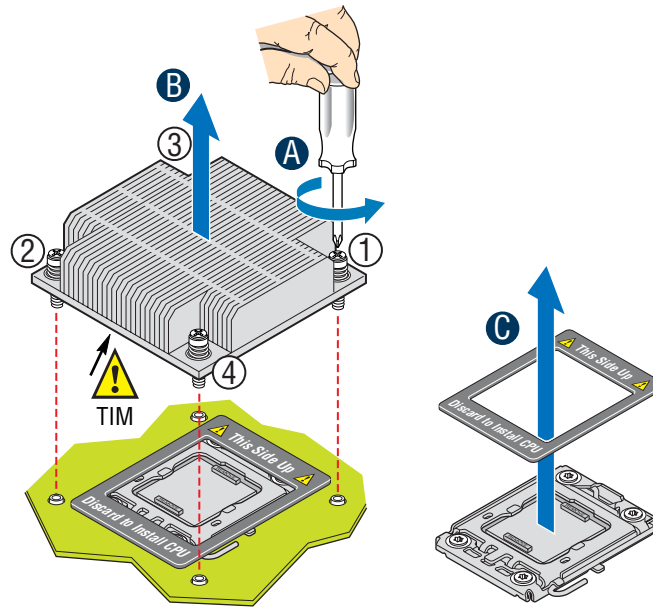
Figure 1. Removing the Heatsink

- Problem:** The current documentation does not properly describe the installation and removal of the heatsink. Careful insertion and removal of the heatsink is required to prevent damage to the heatsink screws or backplate.
- Implication:** There is a possibility of damage to the heatsink if proper steps are not followed.
- Status:** Corrections incorporated into the latest version of the following Service Guides:
- Intel® Server System SR1600 Service Guide (Intel Order Number: E52880-003)
 - Intel® Server System SR1625 Service Guide (Intel Order Number: E52881-003)
 - Intel® Server System SR2600/SR2625 Service Guide (Intel Order Number: E51243-003)
- Workaround:** Perform the steps outlined below for installation and removal of the heatsink to avoid damage.

1. Loosen the four captive screws on the heatsink corners in a diagonal manner according to the numbers shown in **Error! Reference source not found.** as follows:
 - Starting with the screw at location 1, loosen it by giving it **two rotations** in the anticlockwise direction and stop. (**IMPORTANT:** Do not fully loosen.)
 - Proceed to the screw at location 2 and loosen it by giving it two rotations and stop.
 - Loosen screws at locations 3 and 4 by giving each screw two rotations and then stop.
 - Repeat steps 1a through 1c by giving each screw two rotations each time until all screws are loosened.
2. Do one of the following:
 - If removing the heatsink for the first time, do the following:
 - i. Lift the heatsink from the board.
 - ii. Remove and discard the spacer (see letter “C” in **Error! Reference source not found.**).

- If a processor is already installed, do the following:
 - i. Twist the heatsink slightly to break the seal between the heatsink and the processor.
 - ii. Lift the heatsink from the processor. If it does not pull up easily, twist the heatsink again. Do not force the heatsink from the processor. Doing so could damage the processor.
