# intel® Technical Advisory

TA-0675-3

December 15, 2003

## Intel® Telco and Industrial Grade Server TIGPR2U 500W AC Power Supply Failure Rate Above Average

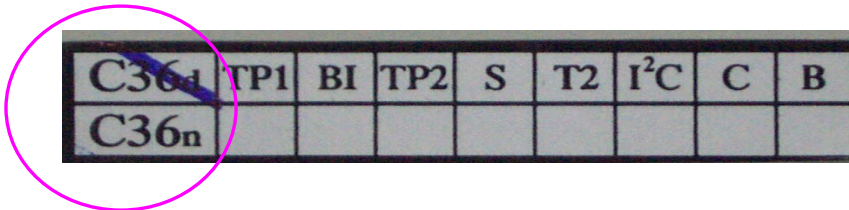
## Figure A

Power supply modules with the listed date codes and serial number ranges listed below have been reworked with a screened diode. The reworked power supply's can be identified with a blue tracking label mark " on the power supply production tracking label in either "C36d" or "C38d" (Figure A) box that is located on the release handle (figure B) of the 500W module.

(Note: Either "C36d" or "C38d" will have a blue slash if the power has been reworked. If there is **NOT** a slash mark in either "C36d" or "C38d" boxes and there are markings in other boxes the power supply has **NOT** been reworked.

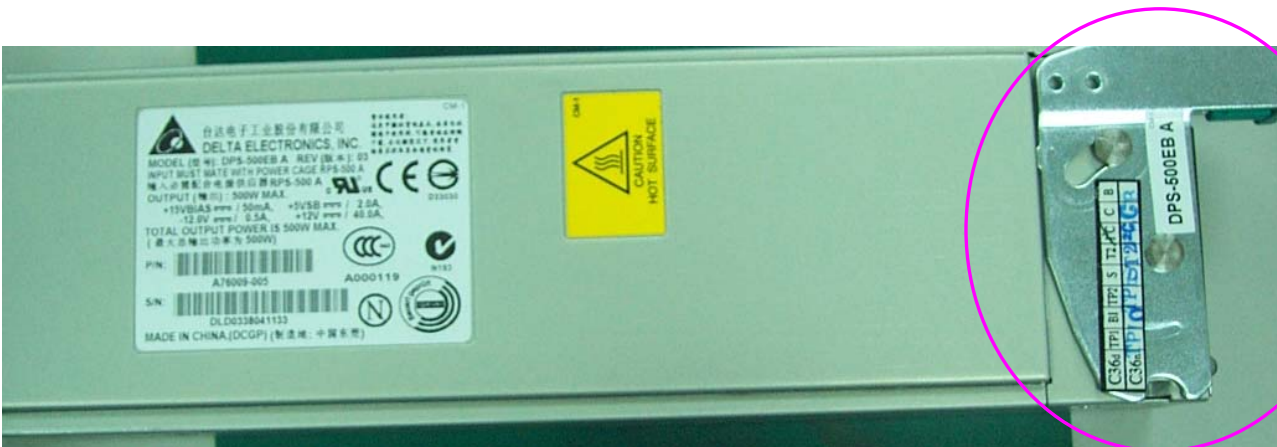
## Figure B

(Note: This is an example **only** and does not display the marking of a reworked power supply)
