# intel® Technical Advisory

TA-0778-1

May 26, 2005

## Improving ambient noise levels when integrating the Intel® Server Board SE7320EP2 with the Intel® Server Chassis SC5275-E

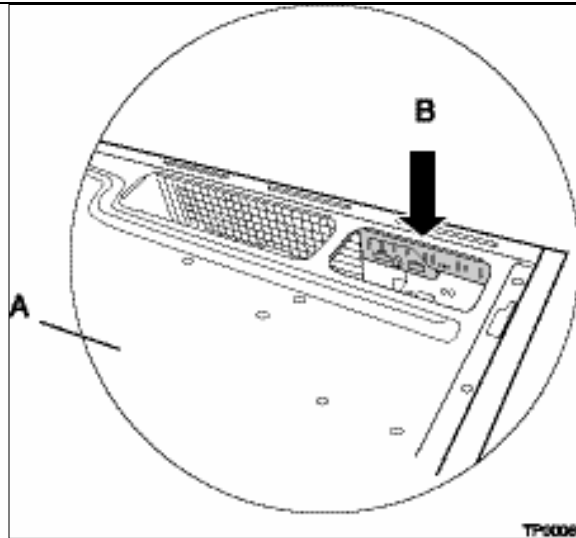
**Figure 1. Front Panel Board Access**

- A. Right side of chassis, access cover removed
- B. Access to Front Panel Board

1. Remove the left access cover.
2. Remove the bezel.
3. Remove the two screws at the rear of the chassis that hold the right access cover in place.
4. Remove the right access cover. A rectangular opening at the right side of the chassis provides access to the front panel board.

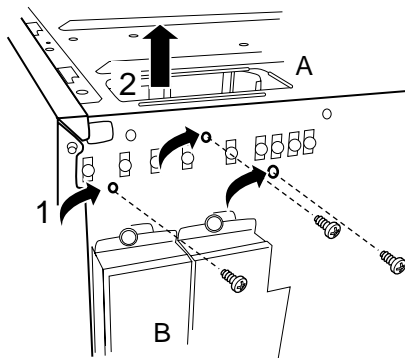
**Figure 2. Removing the Front Panel Board**

- A. Right side of chassis
- B. Front of chassis

5. Disconnect the front panel cable from the front panel board.
6. Remove and save the three screws holding the front panel board to the chassis. See number 1 in the figure below
7. Remove the front panel board through the access hole. See number 2 in the figure below
