# Intel Technical Advisory

TA-0921-2

## AXXRSBBU4 Thermistor Mechanical Damage Results in Incorrect Battery Temperature Being Reported.

AXXRSBBU4, MM# 891157

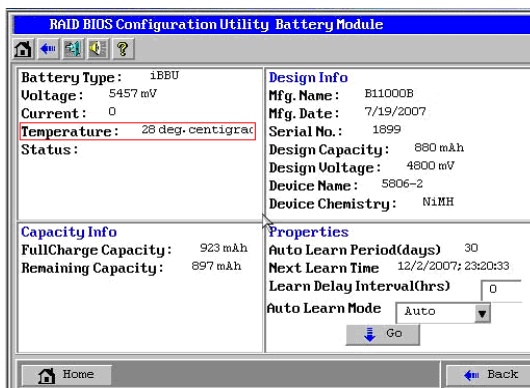
Figure 1

Intel has found that some AXXRSBBU4 may experience an issue with a damaged thermistor. The thermistor damage results in extreme battery temperature values being reported which results in triggering the BBU overheating protection mechanism and prevents the battery from charging. The typical symptom of this issue is a temperature value ~65512 degrees C; however, a value below 16 degrees C can also be reported.

Temperature values reported by the thermistor can be viewed in RAID BIOS Console utility (see Figure 1) or in the RAID Web Console 2 utility (see Figure 2).

Customers may review the AXRSBBU4 temperature values in RAID Bios Console or RAID Web Console 2. Batteries that display an abnormal temperature as described above may be returned for warranty replacement. Battery returns should be managed through the standard product RMA process. Please indicate that you are calling regarding TA# 0921-2, and have the following information when you call; the part number requested, and the serial number(s) for the system(s) or board(s) needing the replacement part.
