# intel® Technical Advisory

TA-718-1

September 2nd, 2004

## Intel® Server Board SE7520BD2 SuperI/O & R1H9 resistor PCB rework

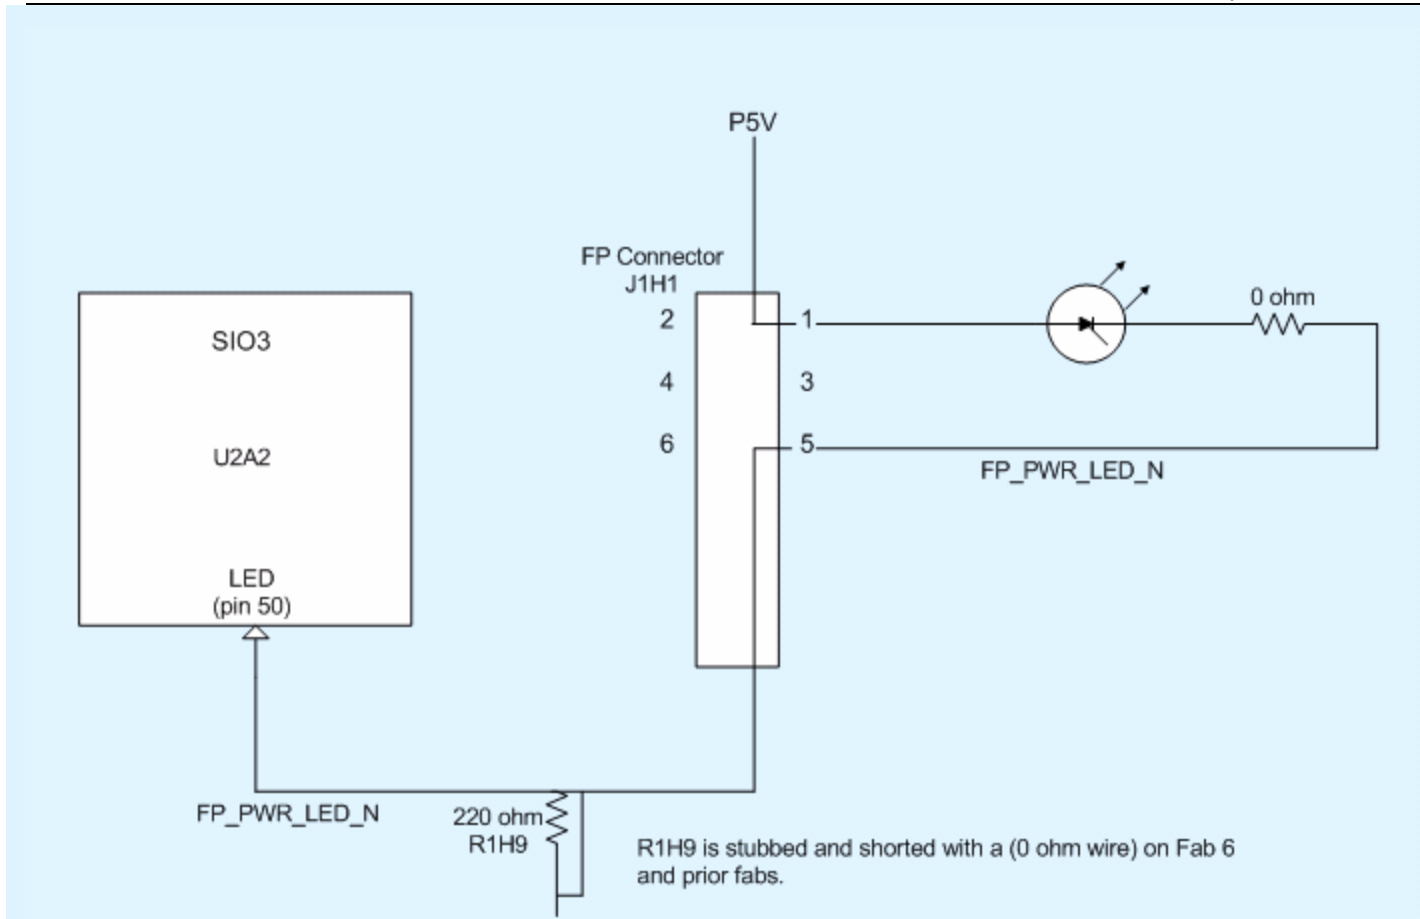
Specifically, the front panel LED off of the Super I/O controller (SIO3 - silkscreen U2A2) was incorrectly set to operate at 50mA of current instead of operating at 15mA designed for the Super I/O controller. This circuit was not initially connected correctly on all Fab6 production boards. In other words, the 220 ohm R1H9 resistor was not connected in series between pin 5 of the J1H1 connector and pin 50 of the National\* SIO3 Super I/O chip. As a result, the circuit incorrectly allows 50mA of current to flow. **Figure 1** below shows how the circuit was initially incorrectly connected on Fab6 boards. Notice in **figure 1** that only one half of the R1H9 resistor is connected and the other half is left as an open instead of being correctly connected to the FP\_POWER\_LED\_N signal. If it had been connected correctly in series the circuit would correctly operate at 15mA of current. If said circuit runs at 50mA for an unspecified amount of time it is possible the Front Panel Power LED will eventually fail due to excess current.

**Figure 1: Incorrect placement of the 220 R1H9 resistor (bottom half should be connected to pin 5 in series).**

Incorrectly connected trace route on Fab6 Printed Circuit Boards for the R1H9 220 ohm resistor.

On all fab 604 boards the 220 ohm resistor (R1H9) will be correctly serially connected with the following 3 changes:

- 1) Cut the PCB top layer trace that connects the FP\_POWER\_LED\_NP signal (pin 5 of J1H1) to the R1H9 resistor
- 2) Cut the PCB top layer trace between pin1 to pin2 of the R1H9.
- 3) Add an external black wire to the PCB connecting pin 5 of the J1H1 connector to the R1H9 220 ohm resistor. The wire will be added prior to attaching the J1H1 Front Panel Connector and will be mounted in a manner to not interfere with the Front Panel Connector.

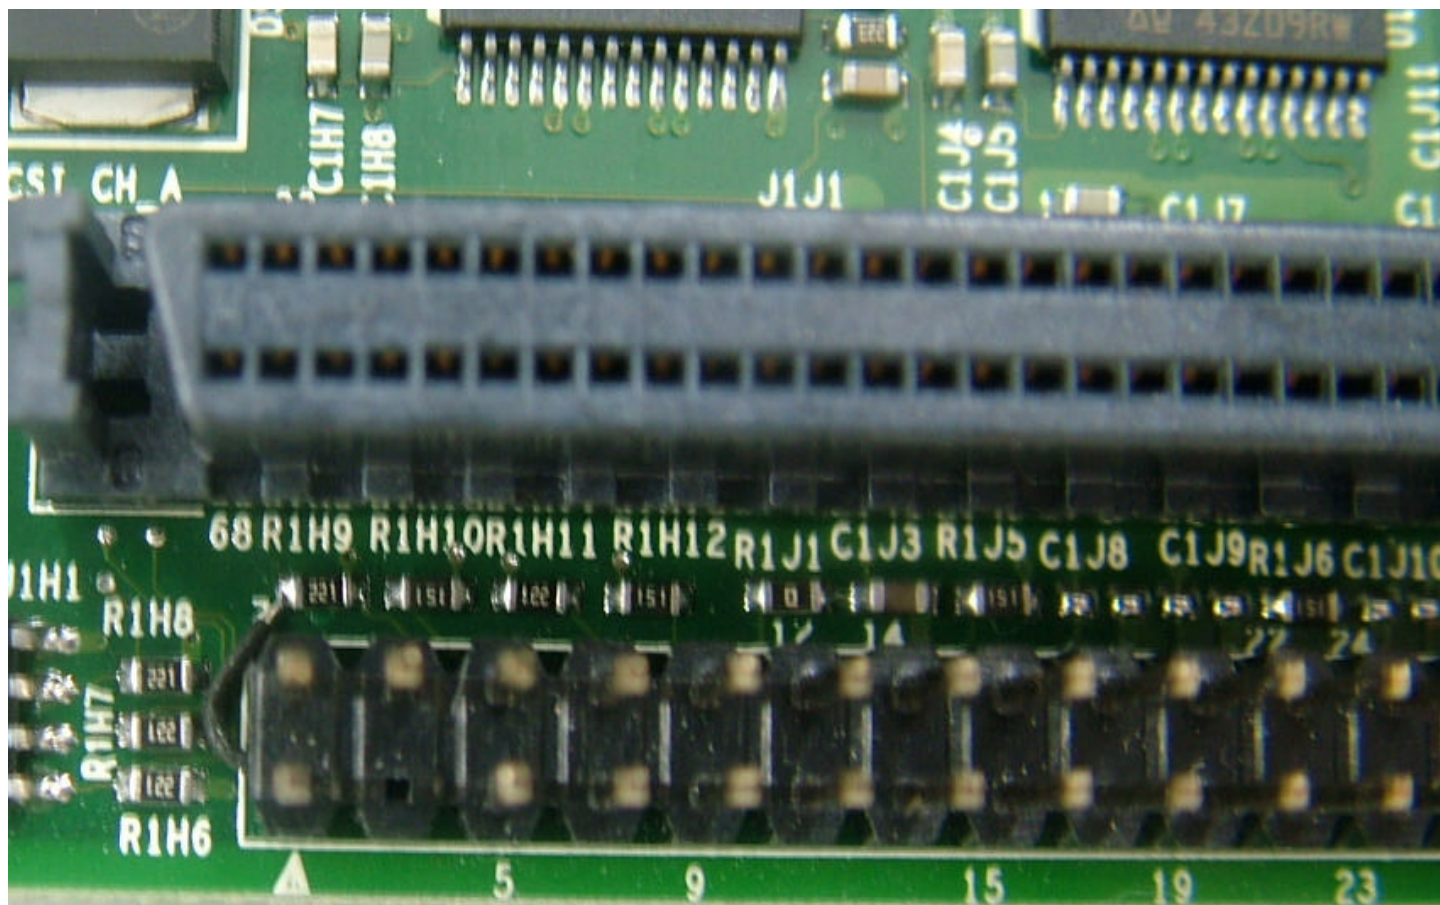
**Figure 2:** Completed picture including the Front panel connector and the wire rework (note: final wire color will be black).

A permanent fix will be incorporated in the Intel® Server Board SE7520BD2 Fab7 version and neither a black wire nor PCB cuts will be included. This permanent fix will be corrected on the PCB which be completed in a future ECO targeted for Q4 2004.
