Intel[®] Pentium[®] III Xeon[®] Processor Specification Update

Release Date: January 2006

Order Number: 244460-043

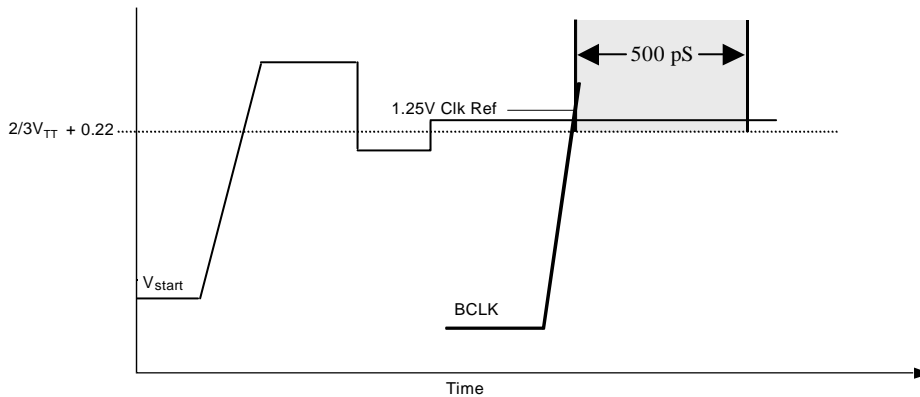
Intel has characterized the new AGTL+ AC specification for V_{IH(MIN)} on the processor's RS0# signal to be: $(2/3 \cdot V_{TT}) + 0.22$ Volts within 500 picoseconds following the rising edge of BCLK crossing the 1.25-Volt threshold. See below.

Implication: The deviation from the published specification results in decreased noise margin on the RS0# processor input. This decreased noise margin has been observed to be particularly detrimental in system environments where the RS0# processor input is being driven by an I/O buffer with a pull-up device (such as a p-channel transistor) that is switched off mid-cycle. Systems that employ I/O buffers that keep the pull-up device on for the entire cycle are significantly less affected by this erratum. The reduction in noise margin may lead to the generation of BINIT# (when enabled) resulting in a system reset, otherwise this condition may lead to a system "hang" condition.

Workaround: If a system design cannot meet the specification deviation, the following areas should be carefully examined to assure that additional margin exists in order to compensate for any deficit observed with respect to the newly characterized V_{IH(MIN)} specification:

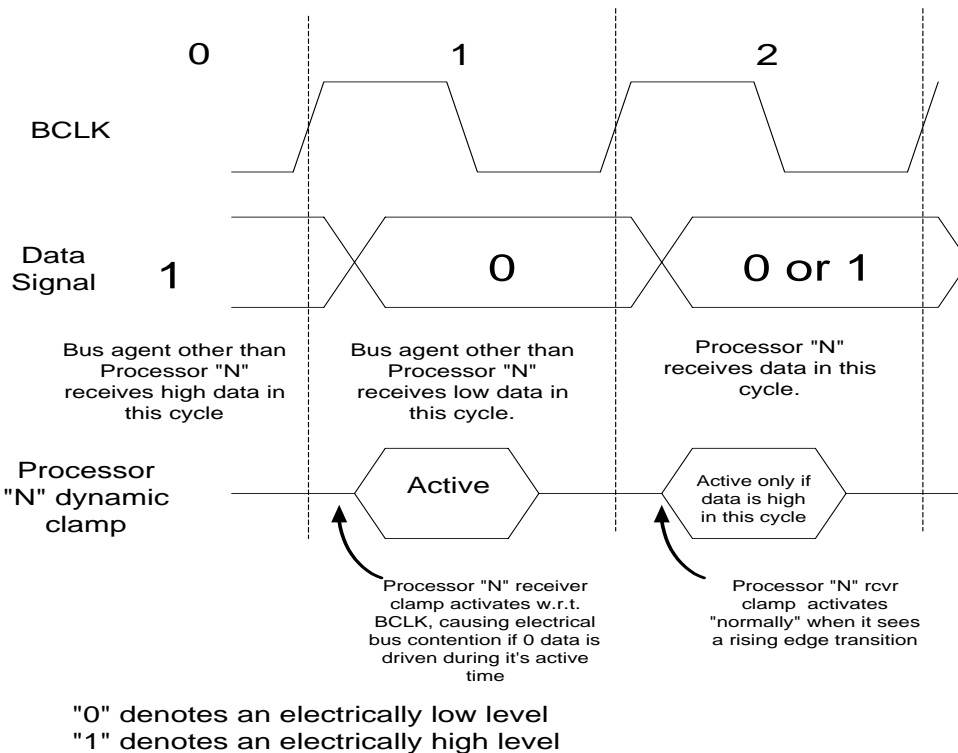
Problem: Falling edge ledge push-out and undershoot may be seen on AGTL+ data and data bus ECC signals. The AGTL+ receiver's dynamic clamp circuit activates (i.e. clamps the signal to an electrically high level) in certain cycles when data is driven to an electrically low level by another agent.

Implication: This erratum only occurs on a processor that does not receive data in that particular cycle. More specifically, this erratum only occurs when a specific processor does not receive data in the current BCLK period, but receives data in the very next period. Therefore, the processor inducing this falling edge noise (on data and data bus ECC signals) will not actually read the data in that cycle. See below for an illustration of this erratum affecting a processor denoted Processor "N". The falling edge ledges and undershoots may affect the signal quality and/or timing at agents that receive data in that cycle. Therefore, the impact of this erratum is highly dependent on system bus design.

Workaround: Evaluate system bus signal quality and timing margin at the valid receiving agent as a result of this falling edge noise. Due to dependence upon system bus design, bus layout may be evaluated to determine the need for improvements in signal quality and timing margin at the valid receiving agent as a result of this receiver-induced falling edge noise.
