intel® Technical Advisory

TA-245-1

January 22, 2000

Some C440GX+ based servers may experience a system hang when add-in cards are installed in PCI slots 5 or 6

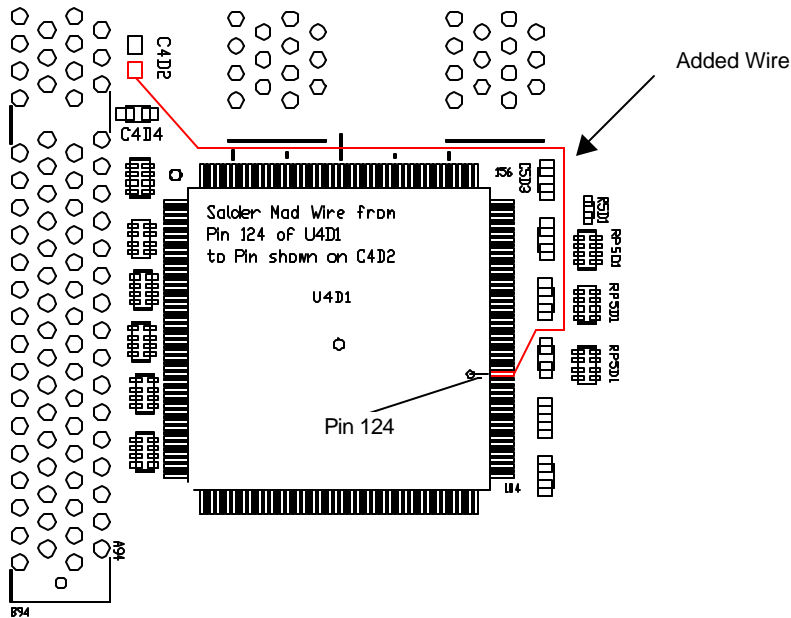
A manufacturing process variation may have affected operation of the 21150BC Bridge chip's internal clamp circuits when exposed to fast edge rates. This process variation may have contributed to a marginal condition between the 440GX chipset and the 21150BC Bridge chip on some C440GX+ server boards.

In addition, hardware changes will be made to the server board design to further decrease the possibility of failures. Intel manufacturing will be implementing a change, for all new shipments, by routing a 5volt signal to pin 124 of the 21150BC bridge chip.

- OEM C440GX+ server boards with BIOS 6.0 and the hardware change will be labeled with a PBA # of 726134-415.
- Boxed C440GX+ server boards with BIOS 6.0 and the hardware change will be labeled with AA# 727281-005.
