Intel[®] L440GX+ Server Board
Technical Specification Update

Order Number: 245145-027

June 2001

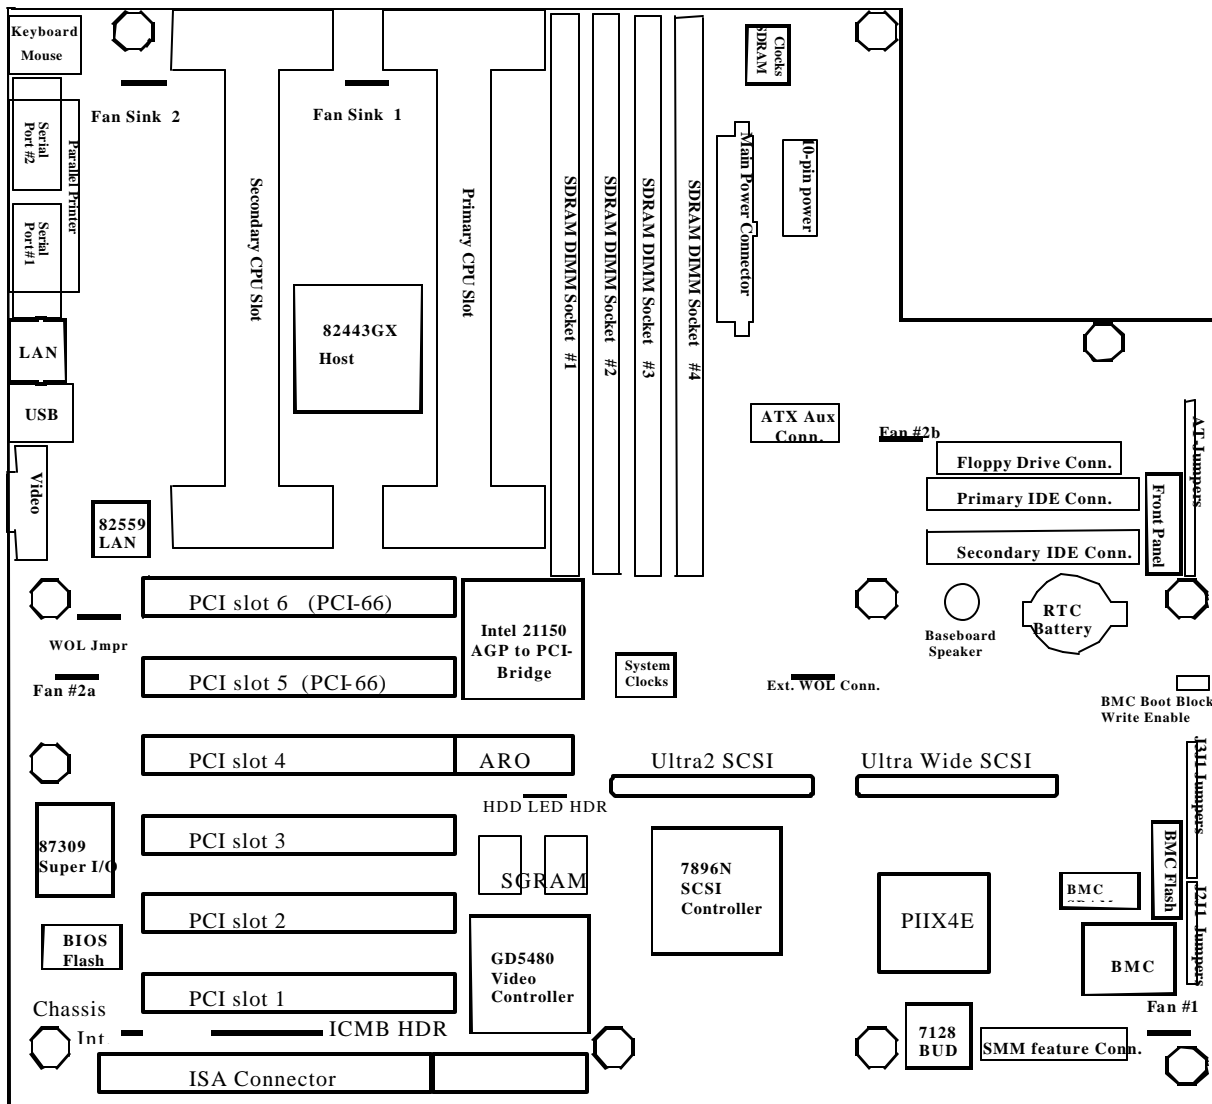
Figure 1-1. L440GX+ Server Board Layout

- Update to the L440GX+ component placement diagram, as shown in the rev 3.0 Technical Product Specification. The new diagram shows the addition of the 10-pin power connector found on L440GX+ server boards having a product code of BOXL440GX-H and later. The 10-pin power connector is used when the L440GX+ server board is integrated into an Intel SC5000 server chassis with redundant power supplies.
