28F200BV/CV
28F002BV

SPECIFICATION UPDATE

Release Date: February 1998

Order Number: 297612-005

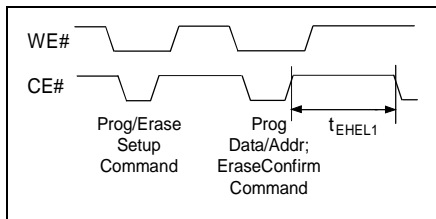
PROBLEM: Due to logic timing problems, modifications in write or address timing are required. Two possible workarounds exist: errata A and B. Refer to the following table to determine the operating which applies to your operation conditions. Where the table says, "One of A or B," one of either erratum A **or** B is necessary for proper functionality. Where it says, "A," only erratum A is needed. "Not Affected" means that this erratum does not effect that operation condition.

x8-Mode Operation		x16-Mode Operation	
	V_{PP} = 5 V ± 10%	V_{PP} = 12 V ± 5%	V_{PP} = 5 V ± 10%	V_{PP} = 12 V ± 5%
V_{CC} = 3.3 ± 0.3 V	One of A or B	A	Not Affected	A
V_{CC} = 5 V ± 10%	One of A or B	One of A or B	Not Affected	Not Affected

IMPLICATION: Applications operating in an affected mode must implement the applicable workaround for proper operation.

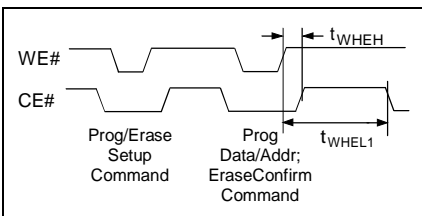
A. t_{WHEH}- CE# Timing Erratum

Due to a logic timing problem, new timing restrictions may be necessary between the WE# and CE# signals during write operations. The timing waveforms and specifications are shown below:

Min	Max	Min	Max	
t_{WHEH}	CE# Hold Time from WE# High	0	no spec	0	5	ns
t_{WHEL1}	CE# Pulse Width High from WE# High	no spec	no spec	110		ns

NOTE:
Erratum timing for t_{WHEL1}, given above, is required only after the second WE# pulse in a WE# controlled write sequence.

Basically, these new errata specifications for WE#-controlled writes require the system timing to:

1. Take CE# to logic high no earlier than WE# goes high and no later than 5 ns after WE# goes high.

2. Hold CE# high for at least 110 ns, starting from the time WE# goes high.
