Intel[®] Core[™] i7-800 and i5-700 Desktop Processor Series

Specification Update

March 2011

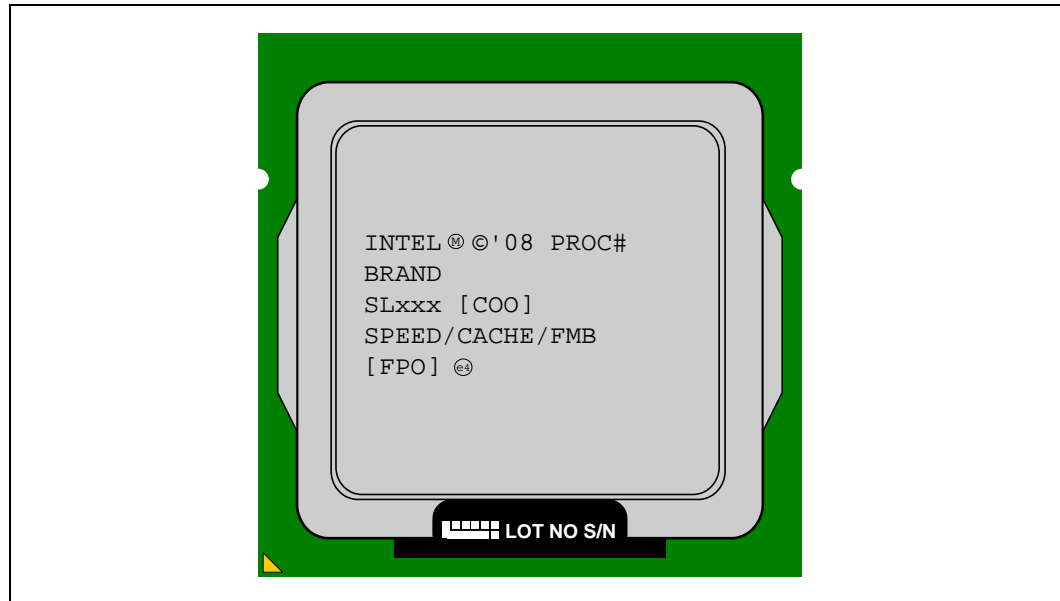
Figure 1. Processor Production Top-side Markings (Example)

The processor stepping can be identified by the following component markings.
