# **Troubleshooting Common System Configuration Issues**

## **Windows\* 95/98 INF Update Utility Bus Master IDE Driver for Windows 95**

*Revision 2.1  
August, 1998*

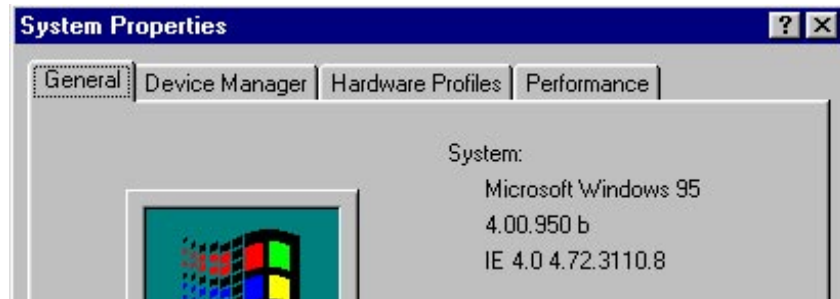
- On the General tab, look for the operating system version, as shown below.

Here's how to translate the version codes:

Windows 95	4.00.950	Original retail version
	4.00.950 a	OEM Service Release (OSR) 1
	4.00.950 b	OEM Service Release (OSR) 2.0 without USB supplement and OSR 2.1 with USB supplement
	4.00.950 c	OEM Service Release (OSR) 2.5
Windows 98	4.10.1998	Original retail version
Windows NT	See Note	See Note

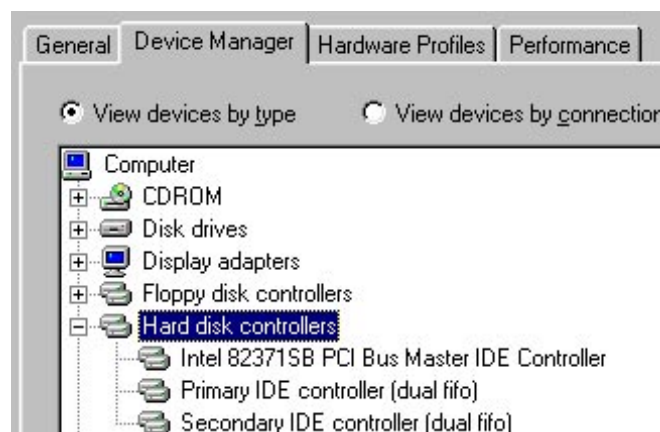
After installing the INF update utility, Device Manager should indicate your system is now using the Intel Hard Disk Controller driver (without the Intel Bus Master driver). The Hard Disk Controllers listing should show:

The entry for the Intel® 82371xB will correspond to the South Bridge (PIIX) component in your system. If these entries do not appear, or other symptoms are observed, see the following troubleshooting section. Note: xB can represent one of AB, SB, FB, or AB/EB, depending on the PIIXn component.

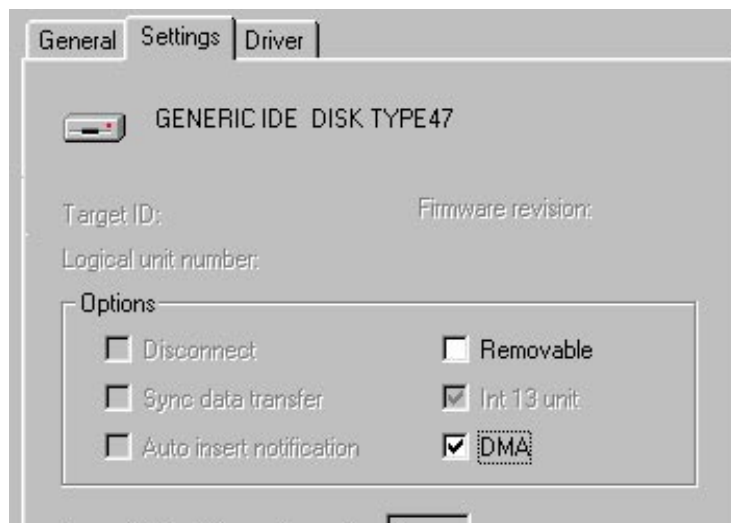
The Intel Bus master IDE driver for Windows 95 should NOT be used with Windows 95 OEM Service Release 2 (OSR2) or later or with Windows 98. In these configurations, use the bus master drivers that are native to the operating system. This can be done using the DMA checkbox in the Windows 95/98 Device Manager:

- Remove the Intel Bus Master IDE Driver (if it was previously installed) by running the install program and choosing the deinstall option when prompted. The Intel Bus Master IDE driver for Windows 95 is located on the web at <http://developer.intel.com/design/chipsets/drivers/busmastr/>
- Click on Start / Settings / Control Panel
- Double-click on the System icon
- Select the Device Manager tab and double-click on your device (hard drive, CD-ROM, etc.)
- Click the Settings tab
- Check the DMA checkbox and click OK
