Intel® Integrated RAID Controller SRCU31LA

Specification Update

December 2002

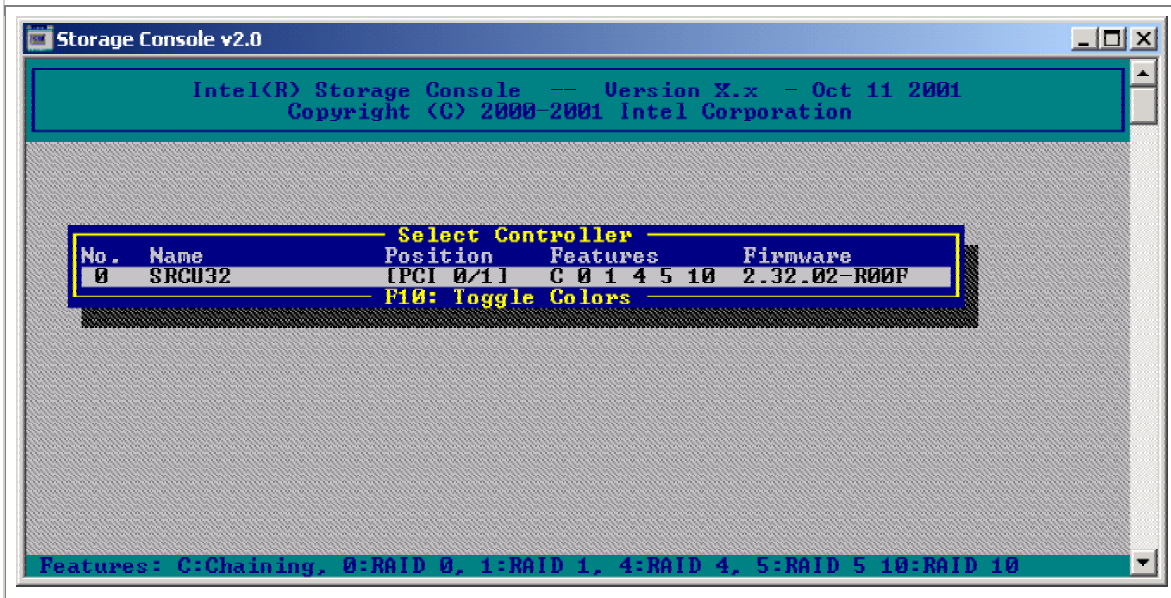
Figure 2. Firmware Version and Application Version Displayed in Storage Console
Storage Console Version Identifier

- While the system is booting, the RAID controller firmware initializes and displays version information on the screen (see [Figure 1](#)). The firmware version is displayed next to the words "FW-Version".
- An alternative method is to use Storage Console for identifying the adapter firmware version. Within Storage Console, select the applicable controller and locate its version under the *Firmware* column on the Select Controller screen (see [Figure 2](#)).

The StorCon version is displayed on the top middle area of the StorCon window (see [Figure 2](#)).
