Intel® Celeron® M Processor

Specification Update

November 2006

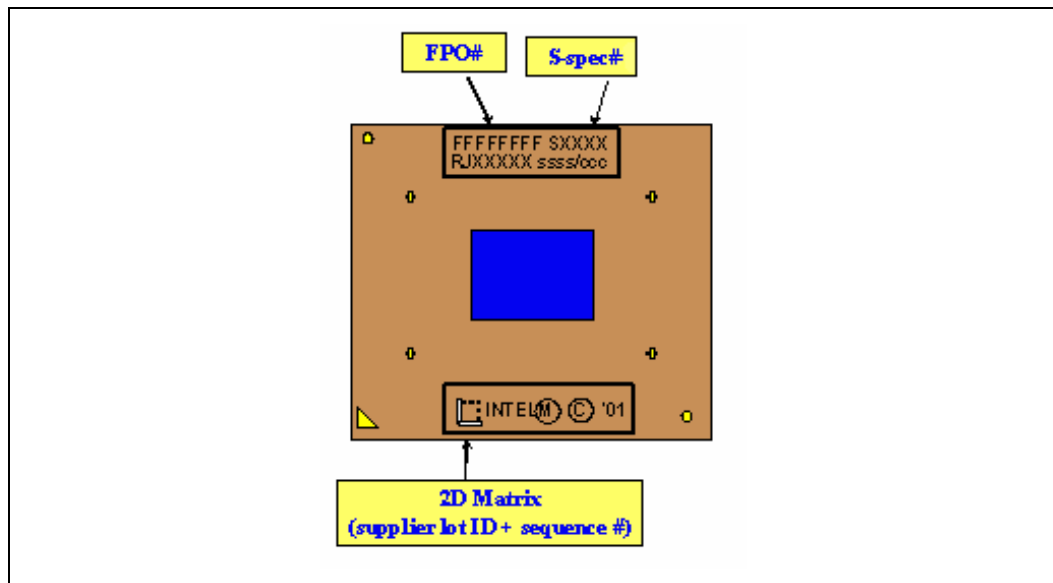
Figure 1. Intel Celeron M Processor (Micro-FCPGA/FCBGA) S-Spec Markings

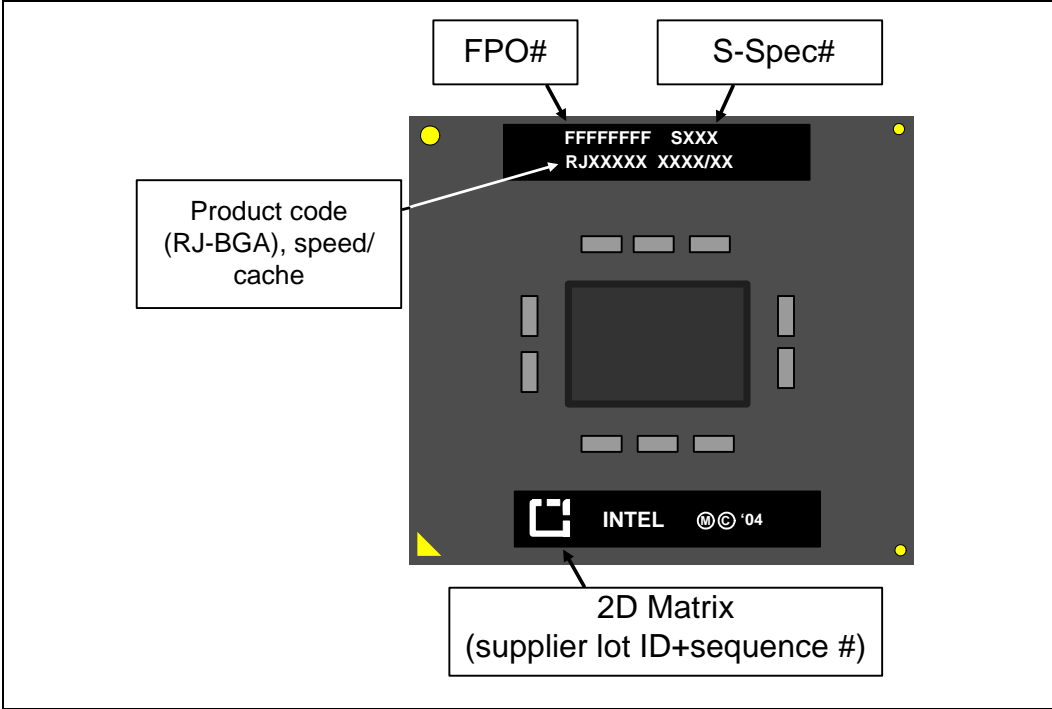
Figure 2. Intel Celeron Processor ULV on 90 nm Process (Micro-FCBGA) S-Spec Markings

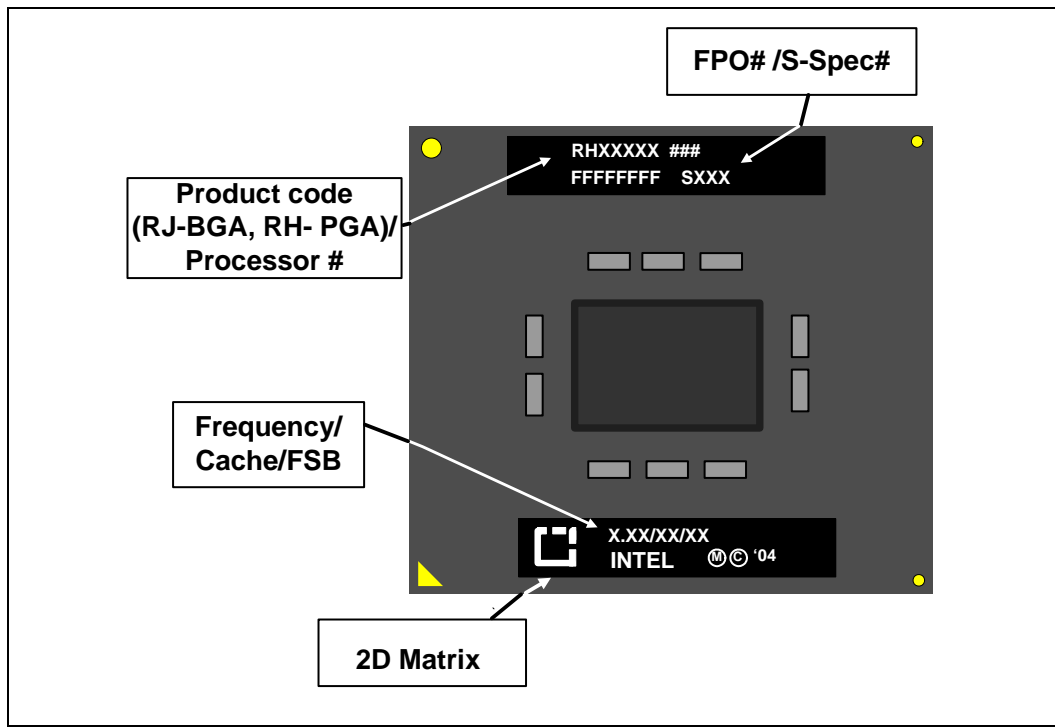
Figure 3. Intel Celeron M Processor on 90 nm Process (Micro-FCPGA/FCBGA) S-Spec Markings

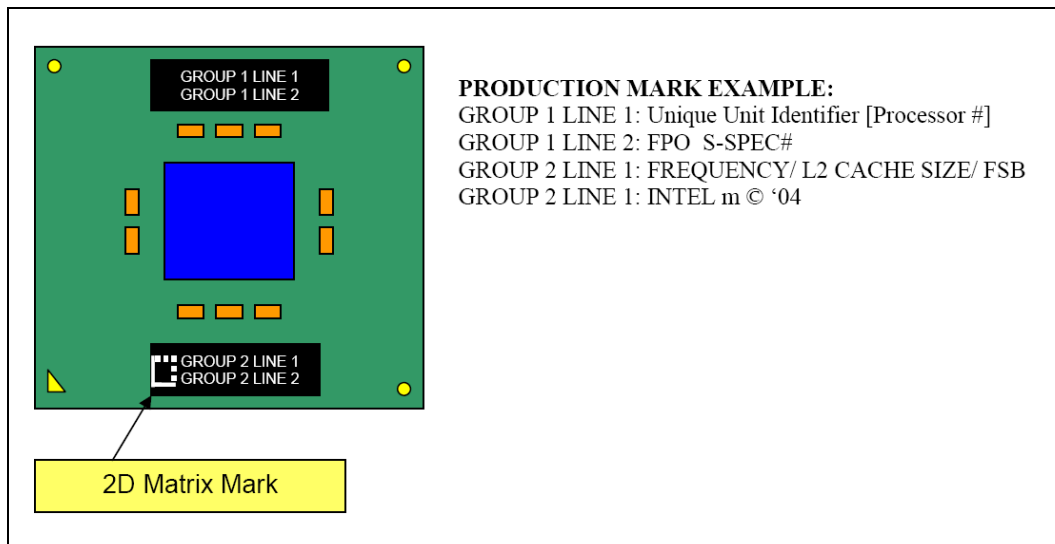
Figure 4. Intel Celeron M Processor on 65 nm Process (Micro-FCPGA/FCBGA) S-Spec Markings

-016	<ul style="list-style-type: none"> • Added Erratum W43 	November 2005
-017	<ul style="list-style-type: none"> • Added Errata W44 and W45 	December 2005
-018	<ul style="list-style-type: none"> • Added Errata W46 – W51 • Removed Specification Clarification W1; refer to Section 18.8 of the <i>IA-32 Intel® Architecture Software Developer's Manual, Volume 3B</i> for detailed Time Stamp Counter information • Updated Processor Identification Table 1 	January 2006
-019	<ul style="list-style-type: none"> • Added Errata W52 – W66 • Updated Errata W18, W34 • Added General information on Intel Celeron M Processor on 65nm process • Updated Summary of Changes Table to include CPU Signature = 06E8h (Intel Celeron M Processor on 65 nm process) • Updated Processor Identification Table 1 • Updated Affected Documents Table 	April 2006
-020	<ul style="list-style-type: none"> • Updated Errata information as indicated in the Summary Tables of Changes • Updated Processor Identification Table 1 • Added Figure 4 	May 2006
