Dual-Core Intel® Xeon® Processor 2.80 GHz

Specification Update

October 2006

Document Number: 309159-008

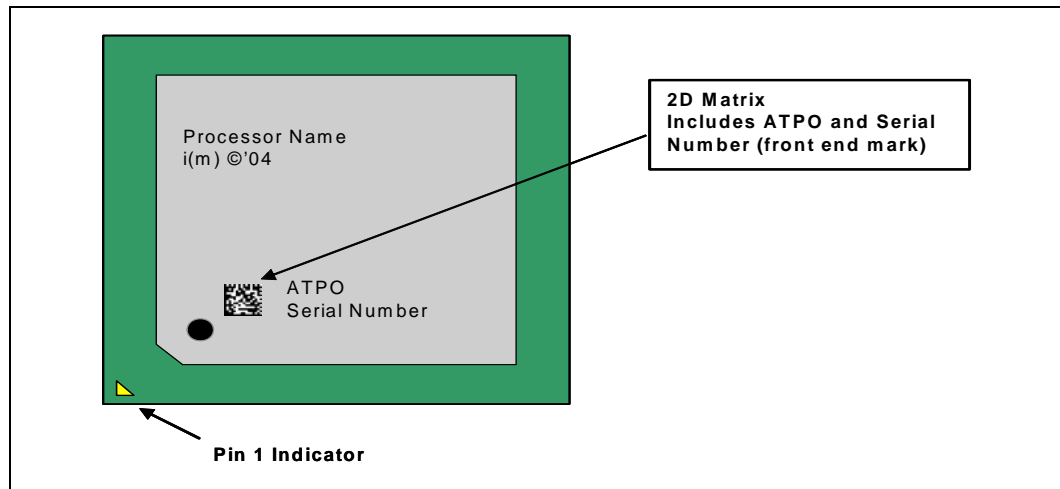
Figure 1. Top-Side Processor Marking Example

Dual-Core Intel® Xeon® Processor 2.80 GHz Package Markings (604-pin FC-mPGA4 package)

- NOTES:**
1. All characters will be in upper case.
 2. Drawing is not to scale.
