Instructions for Recovery BIOS Update

In the unlikely event that a BIOS update is interrupted, it is possible the BIOS may be left in an unusable state. The recovery process requires the chassis to be opened to move the onboard BIOS Configuration Jumper.

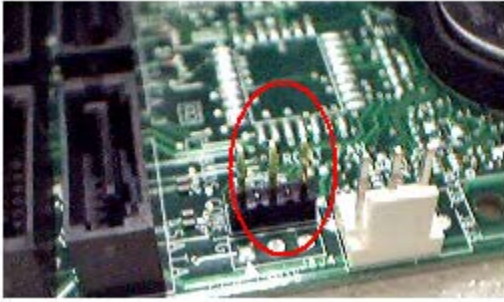
Image 1: Jumper removed
(BIOS Recovery Mode)

- a. Download the iFlash BIOS Update file (example filename: VA84510A.86A.0056.P20.IB.EXE)
 - b. Double-click the *.EXE to extract all files.
 - c. Double-click the SW.EXE file to extract additional files, one of which is the .BIO file.
2. Copy the recovery file (*.BIO) to a USB device.
 3. Plug the device into a USB port of the target computer.
 4. Shut down the computer and unplug the AC power adapter.
 5. Open the chassis and remove the BIOS Configuration Jumper. See the Technical Product Specification for details including the location of this jumper.

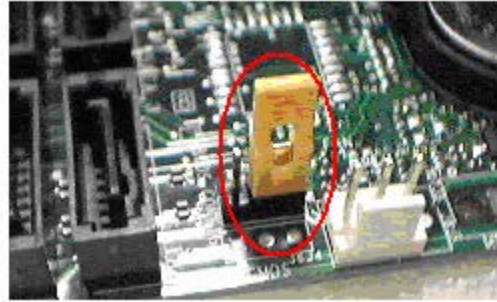
Image 2: Jumper in place
(Normal Mode)

8. The computer will either turn off when the recovery process is completed or it will prompt you to turn it off.
9. Remove the USB device.
10. Replace the BIOS Configuration Jumper (image 2 above).
11. Close the chassis.
12. Restart the computer.

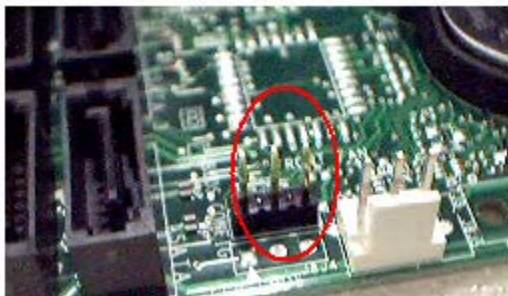
Image 1: Jumper removed
(BIOS Recovery Mode)

2. Copy the recovery file (*.BIO) to a formatted diskette.
3. Place the diskette in the drive (drive A) of the target computer.
4. Shut down the computer and unplug the AC power adapter.
5. Open the chassis and remove the BIOS Configuration Jumper. See the Technical Product Specification for details including the location of this jumper.

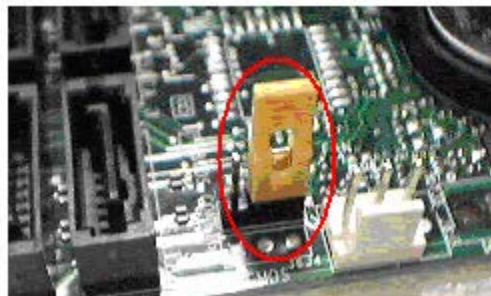
Image 2: Jumper in place
(Normal Mode)

8. The computer will either turn off when the recovery process is completed or it will prompt you to turn it off.
9. Remove diskette from drive A:
10. Replace the BIOS Configuration Jumper (image 2 above).
11. Close the chassis.
12. Restart the computer.

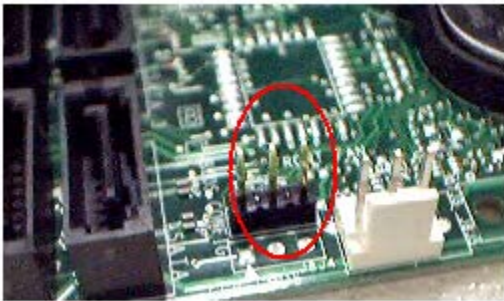
Image 1: Jumper removed
(BIOS Recovery Mode)

2. Copy the recovery file (*.BIO) to a CD.
3. Place the CD in the CD-ROM drive of the target computer.
4. Shut down the computer and unplug the AC power adapter.
5. Open the chassis and remove the BIOS Configuration Jumper (Image 1 below). See the Technical Product Specification for details including the location of this jumper.

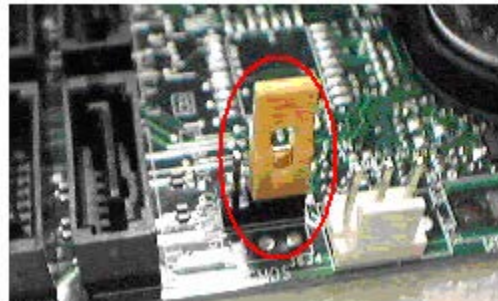
Image 2: Jumper in place
(Normal Mode)

8. The computer will either turn off when the recovery process is completed or it will prompt you to turn it off.
9. Replace the BIOS Configuration Jumper (Image 2 above).
10. Close the chassis.
11. Restart the computer.
